***Hudson County Courthouse
Murals and Historic Finishes Investigation
Jersey City, New Jersey***

May 25, 2012

Written by:
Gillian Randell & Amanda Stauffer,
Conservators
EverGreene Architectural Arts,
450 West 31st Street, 7th Floor
New York, NY 10001
T: (212) 244-2800
Submitted by:
Bill Mensching, Project Manager

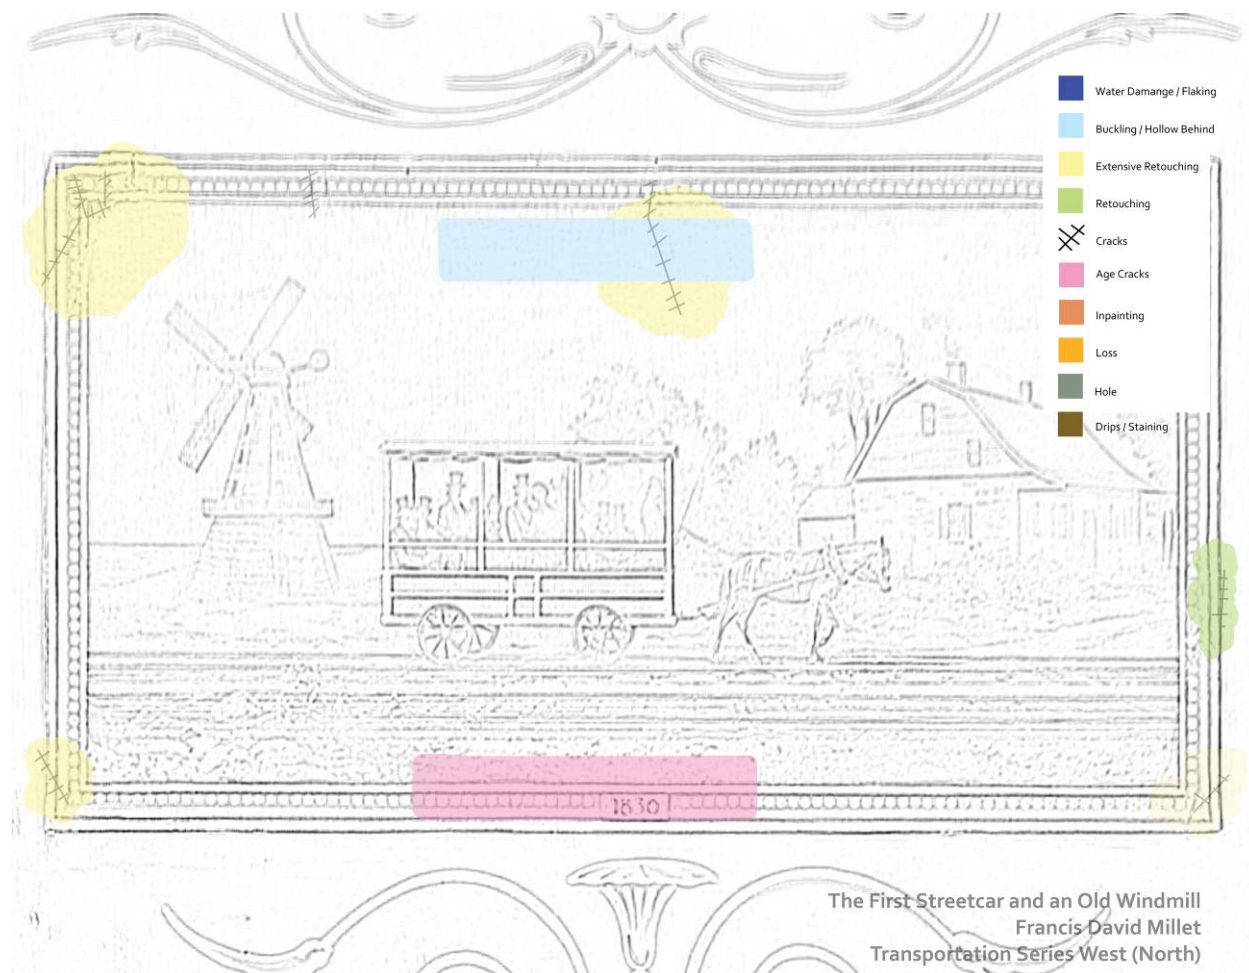
Overall the paint appears relatively stable, with the isolated exceptions of fine craquelure due to age along the central lower horizontal border and minor cracks along the border field, all of which have been well-treated, with the exception of one 6" in from the upper left corner.

The lower right, lower left, and upper left corners, in addition to the central upper edge and the central right edge have a fair amount of inpainting that is well executed and visible only in ultraviolet light. These areas conceal cracks in the paint layer, which have been treated in a sensitive fashion and are well-integrated.

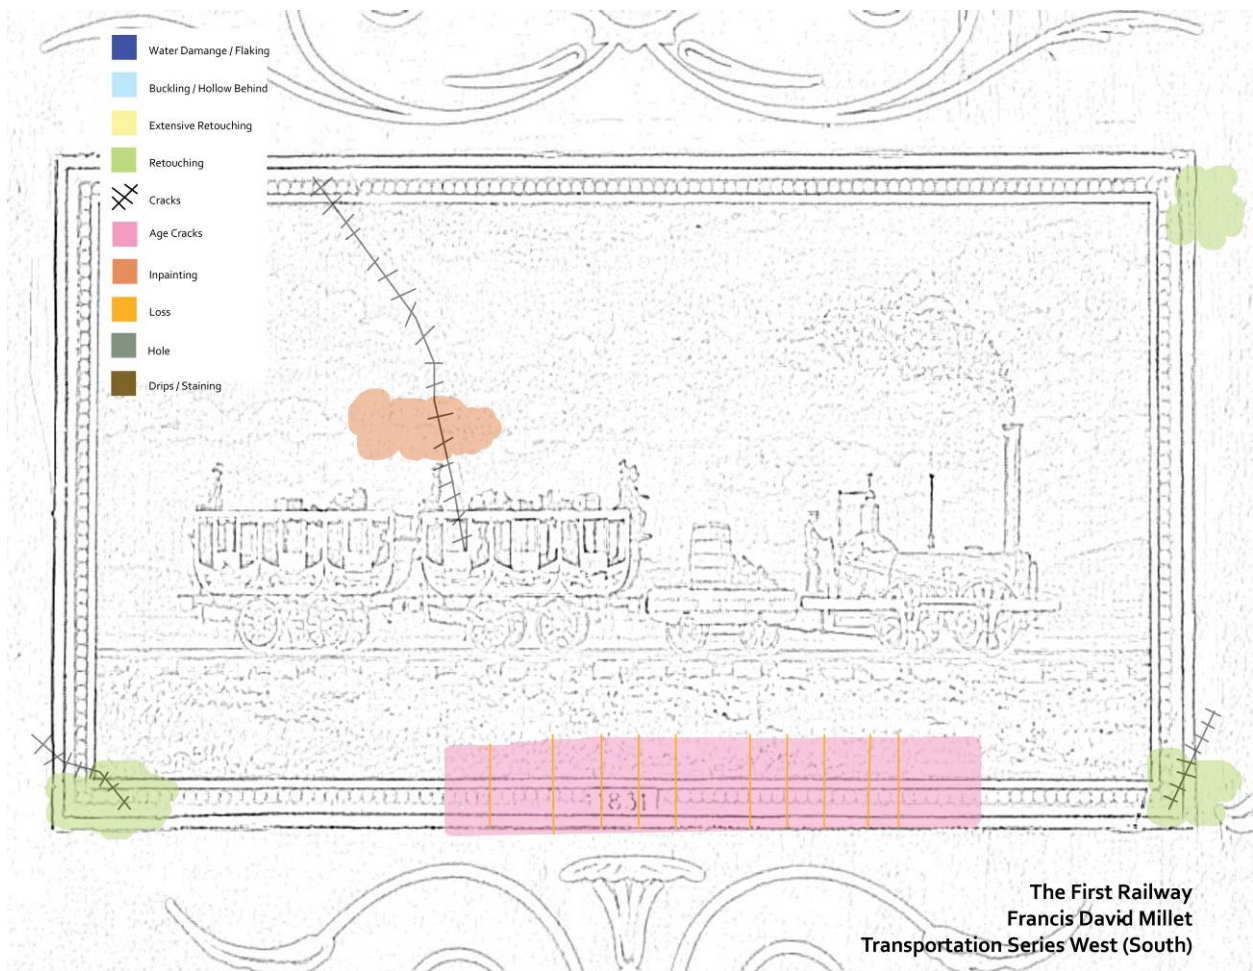
Overall the paint appears relatively stable, with the isolated exceptions of fine craquelure due to age along the lower horizontal border and a large crack running diagonally from the left side of the upper border extending 2/3 of the way down to the right. Cracks in the lower right and lower left corners have been well-treated.

The lower left, lower left and upper right corners, in addition to a cloud to the left of center have a fair amount of inpainting that is well executed, though less well than comparable inpainting in the other seven Millet murals on the second floor. The lower corner areas conceal cracks in the paint layer, which have been treated in a sensitive fashion and are well-integrated.

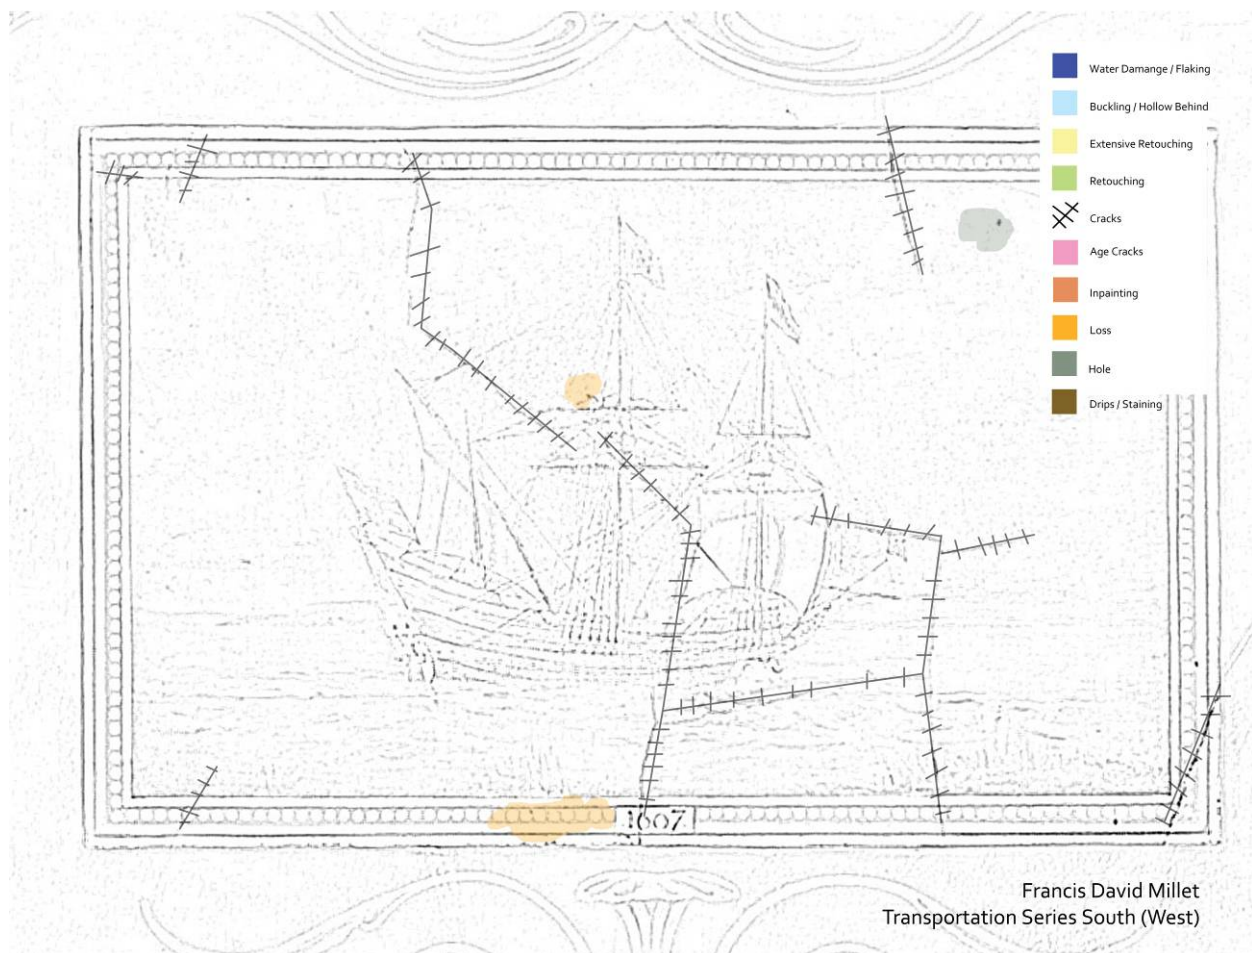
The paint is riddled with long cracks that extend beyond the confines of the canvas and run through the adjacent plaster. There are pin-point paint losses in the upper center and the lower horizontal border.

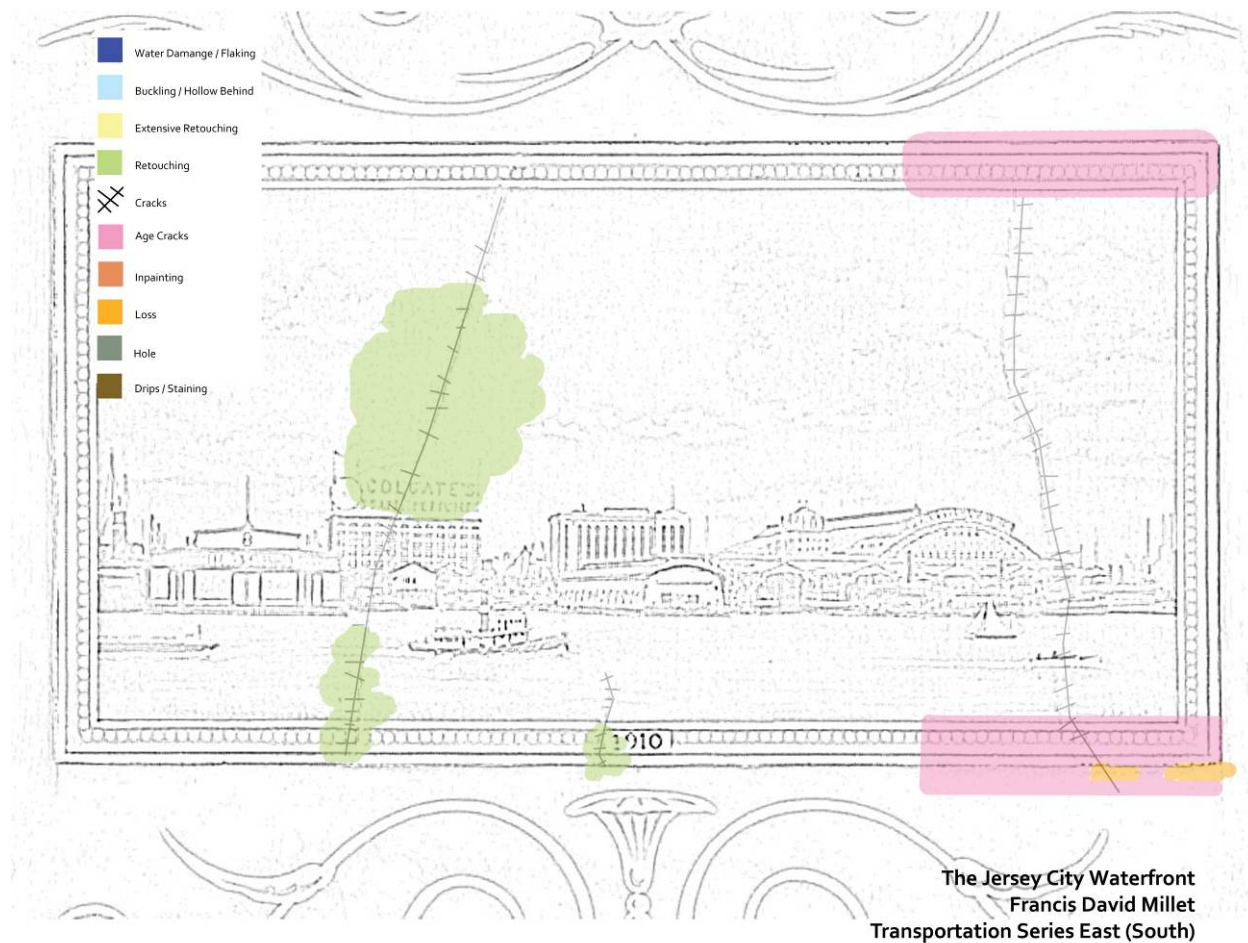
The paint displays two prominent vertical age cracks, which span the surface of the painting. There are localized areas of craquelure at the upper and lower right corners, as well as a small vertical drying crack at the central lower border and minor losses in the lower right corner.

The central lower right edge and the large vertical crack to the left display extensive inpainting. The inpainting is fairly well executed, though still visible to the naked eye.

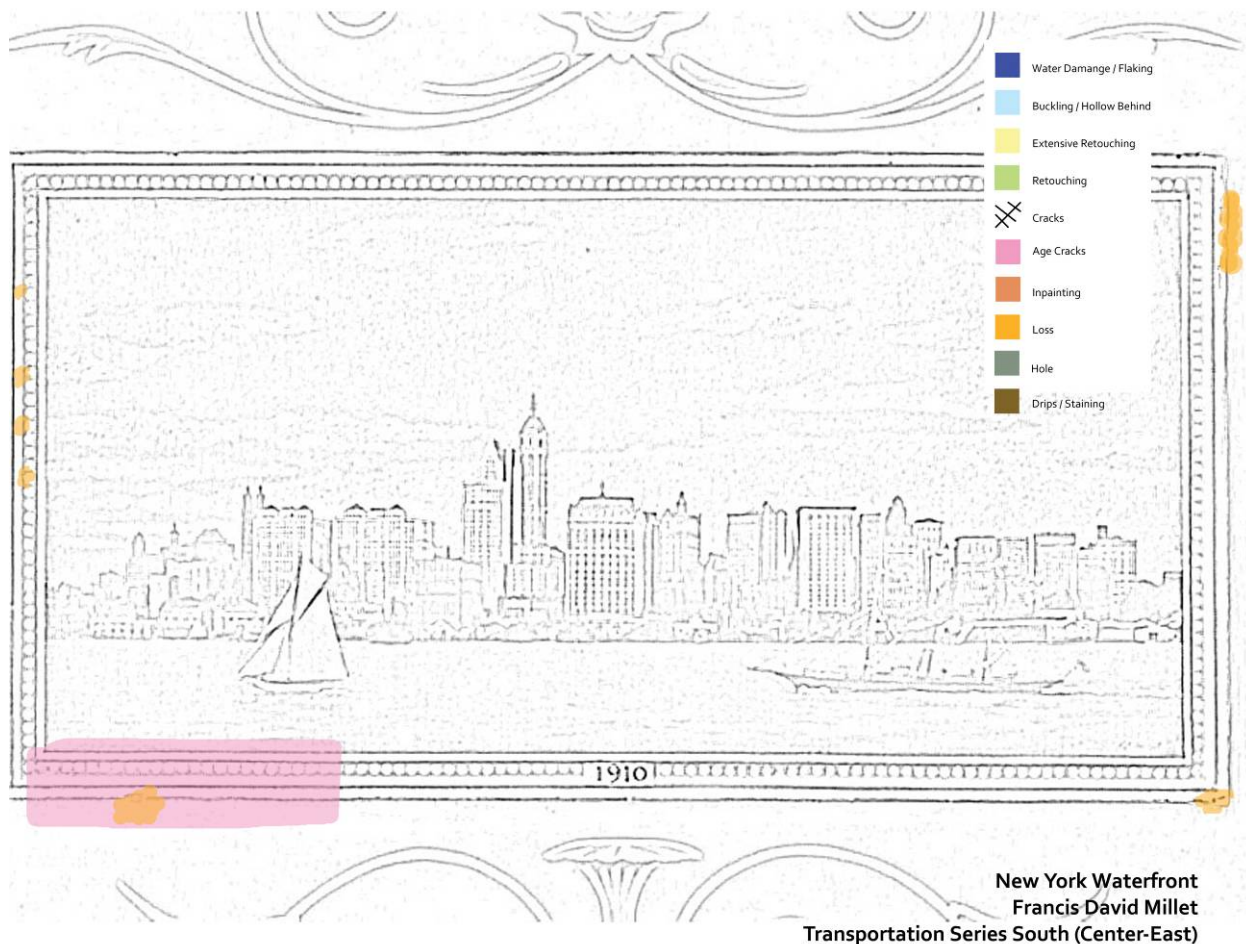
The paint is in very good condition, with isolated areas of minor loss on the upper right, lower right, and left borders. Fine drying cracks and pinpoint loss occurs at the lower left corner, but the field paint appears very well preserved.

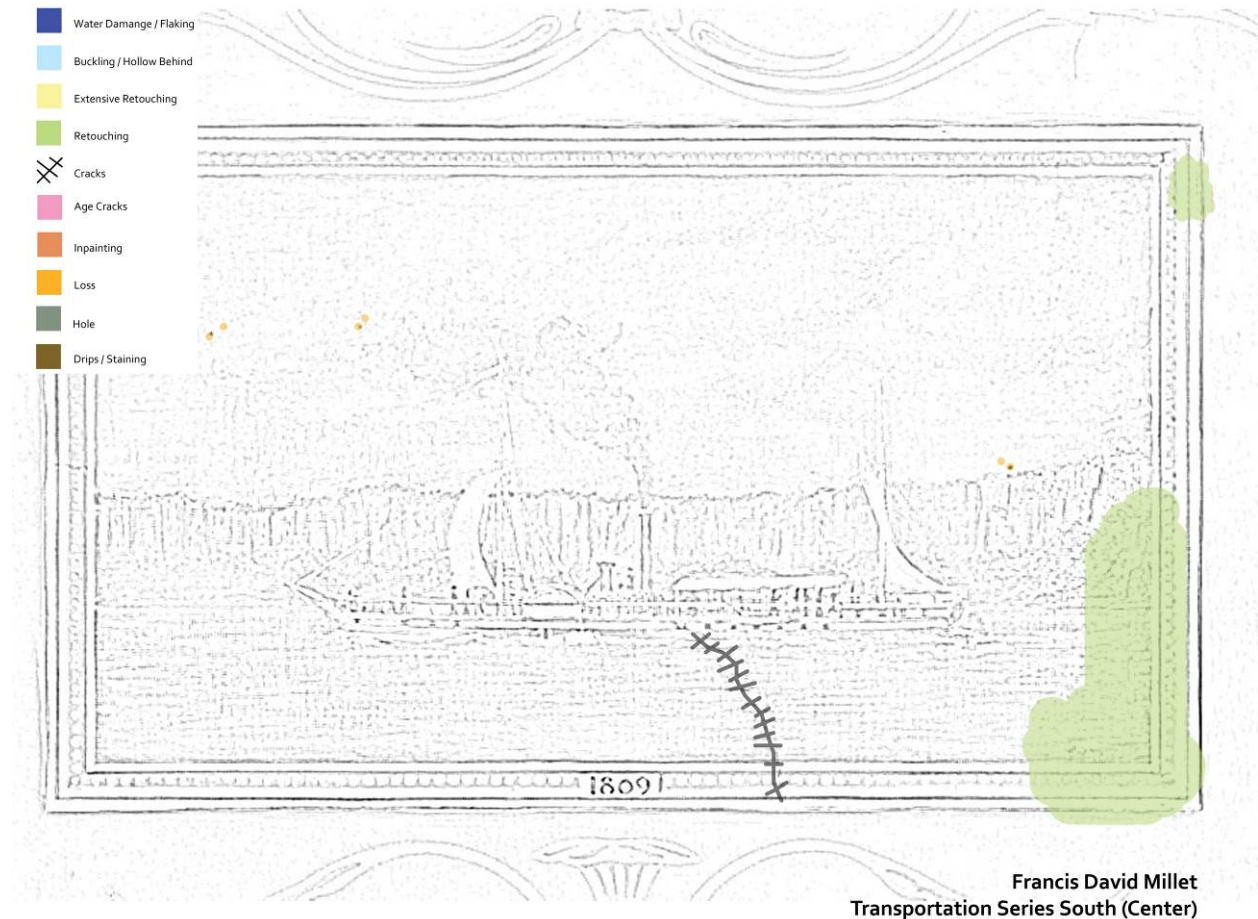
The paint is in good condition, with isolated pinpoint losses in the sky field (two at the upper left, one at the lower right) and a fine age crack to the right of the center, extending vertically 1/3 of the way up the canvas.

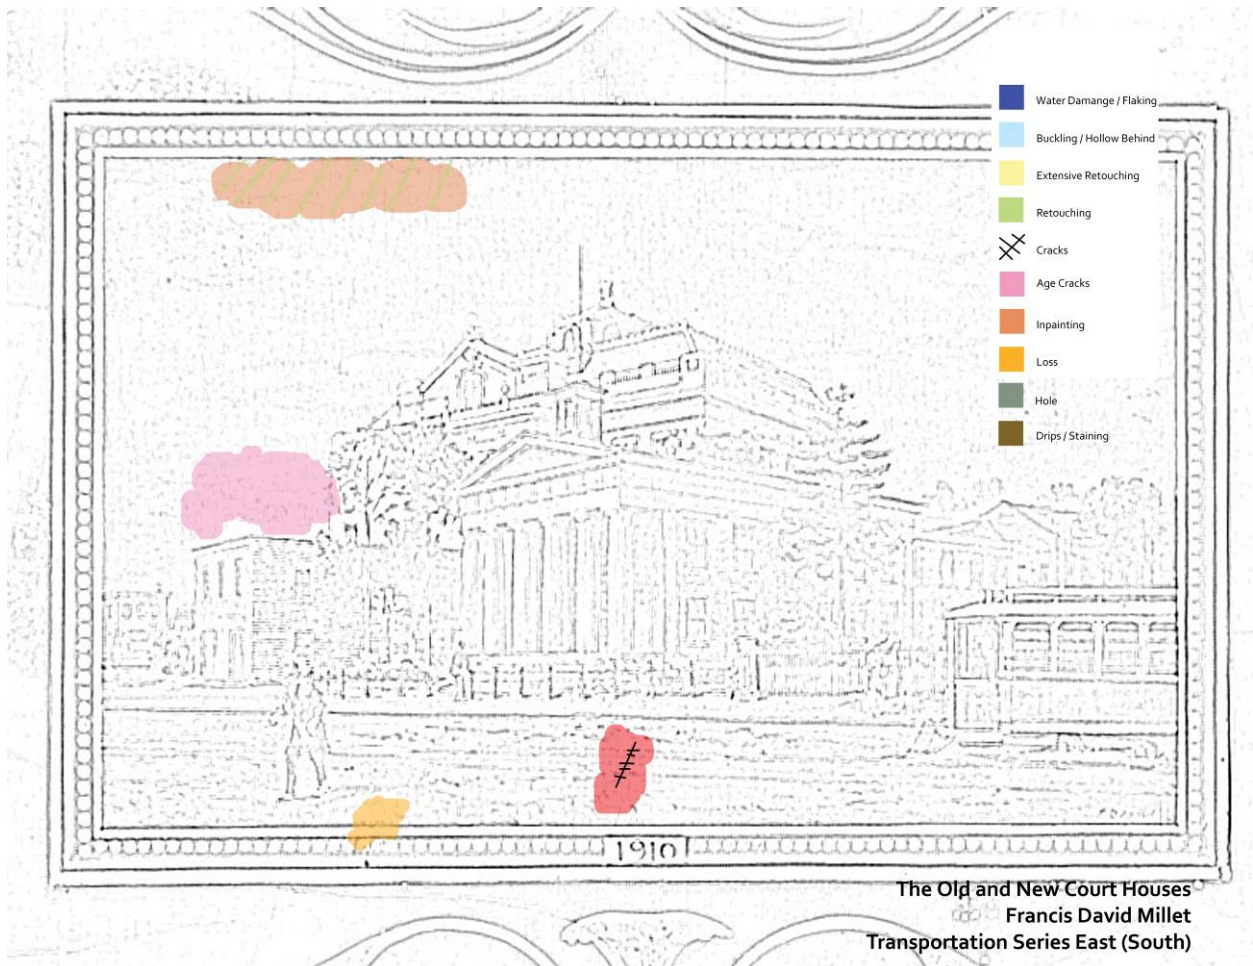
There is a minor area of drying cracks concentrated at the left central field, in addition to a minor loss at the horizontal border below it. A small age crack (2"L) extends up from the "1910" painted plaque.

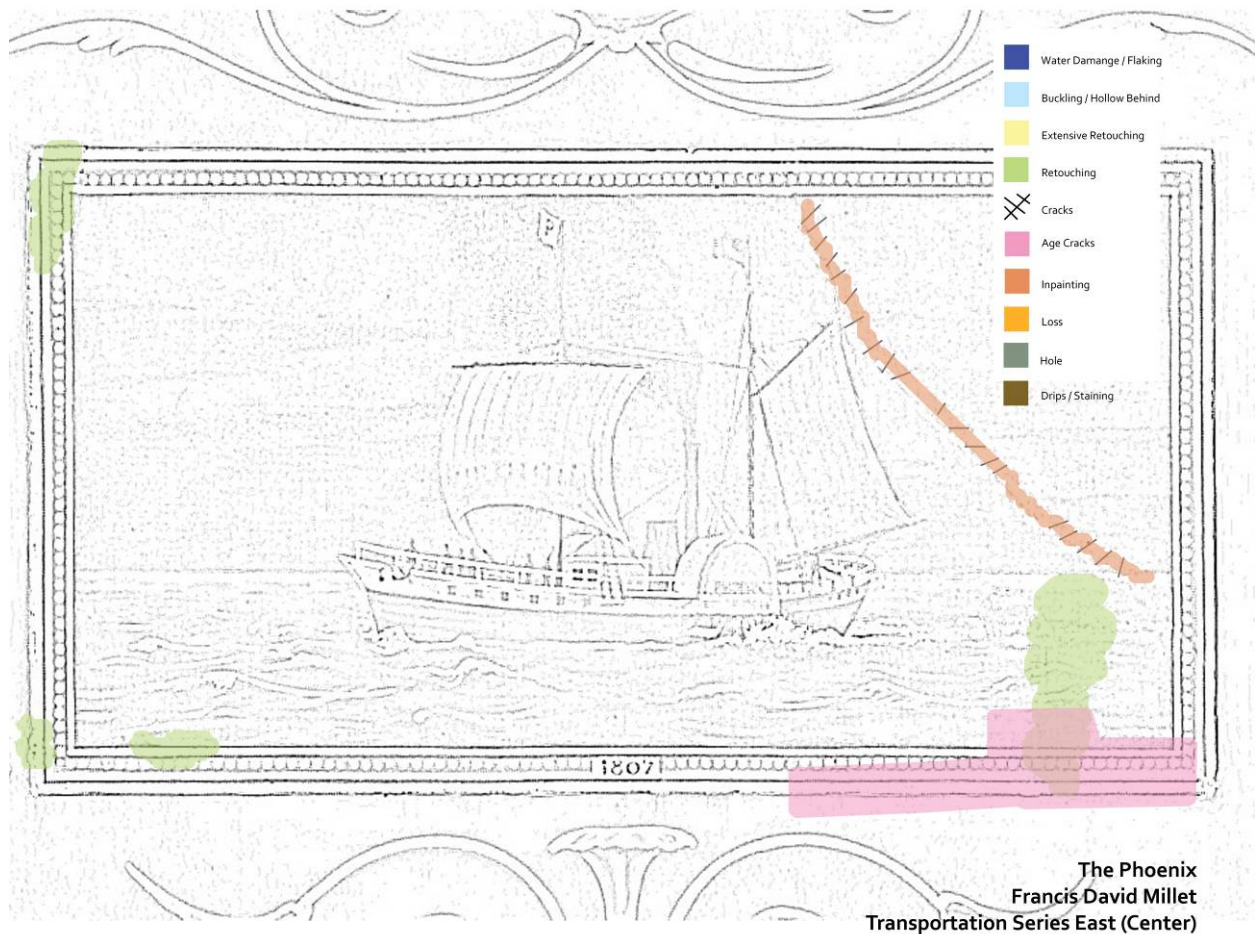
Prominent age cracks at the upper left corner and along the right 1/3 of the painting have been repaired and inpainted. Fine drying cracks at the lower left corner could benefit from consolidation.

The upper left corner, in addition to two areas at the lower left corner, and along the two prominent age cracks at the right, have been retouched. The inpainting is well-executed though visible in raking light.

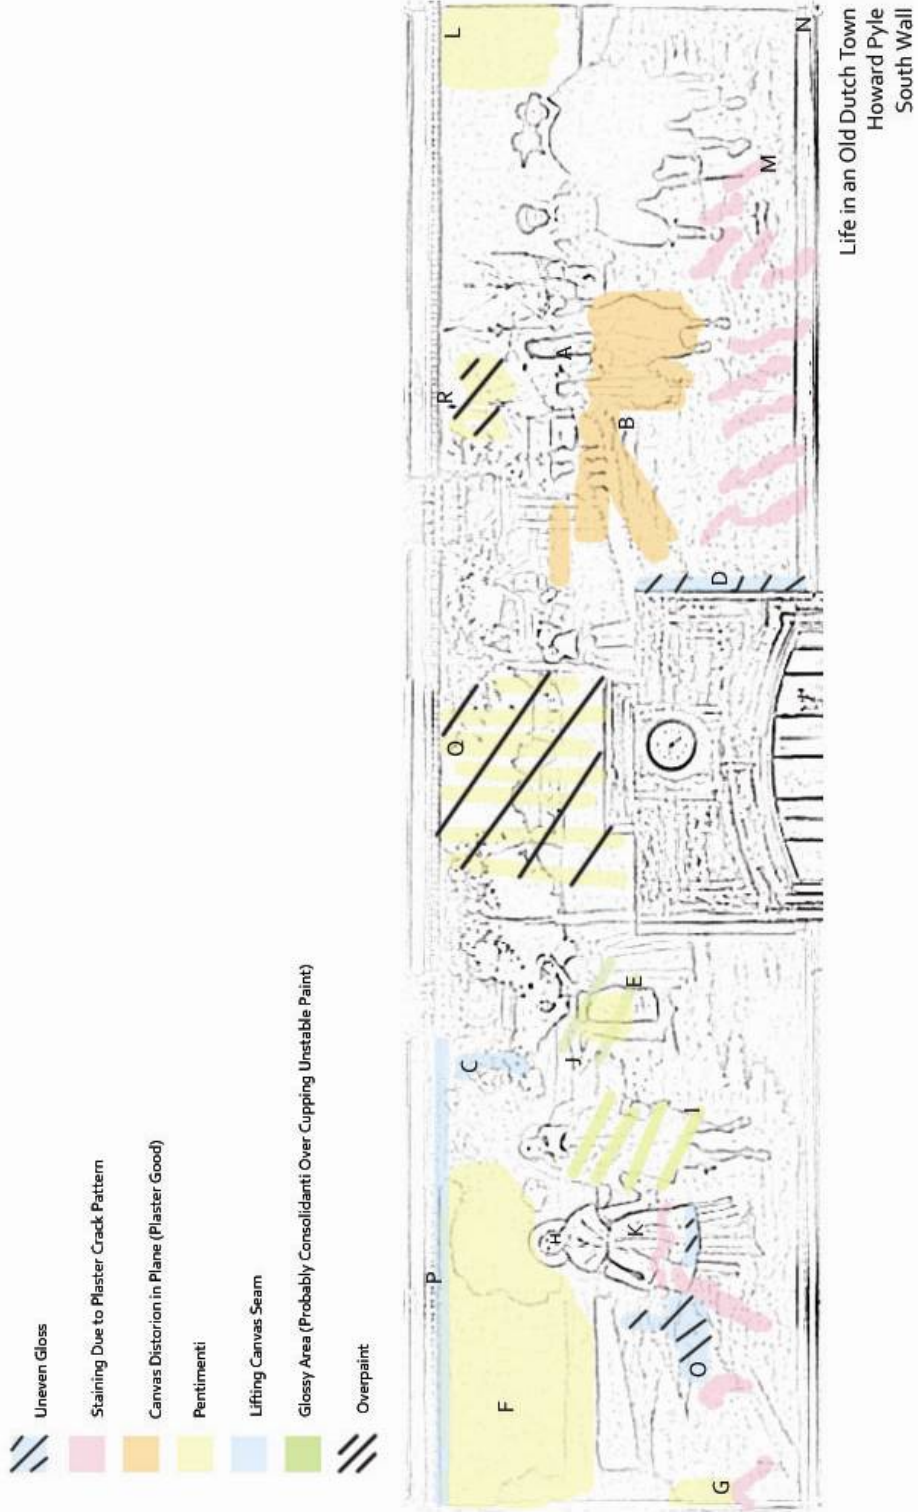
Area K: lower left, staining emanating from hairline plaster fissures

Area M: lower right, staining emanating from hairline plaster fissure

There appears to be post-historic paint on this mural, specifically in areas that had been previously water stained (center above clock). The *pentimenti* appear to be original.

Overall the canvas appears well attached and in plane. There is evidence of some dimensional changes, possibly responding to water damage or drastic fluctuations in temperature and relative humidity. In some areas the canvas is slightly distorted, it is predominantly in plane but slightly raised along an irregular pattern, like the effect of a quilted fabric. The plaster is sound in these areas.

Although the entire surface was not sounded due to limited access, a majority of the surface was assessed. Overall the plaster appears to be stable and in plane. There is some staining on the surface of the canvas, which appears to correlate with hairline plaster fissures. These are stable areas and characteristic of natural settling and aging.

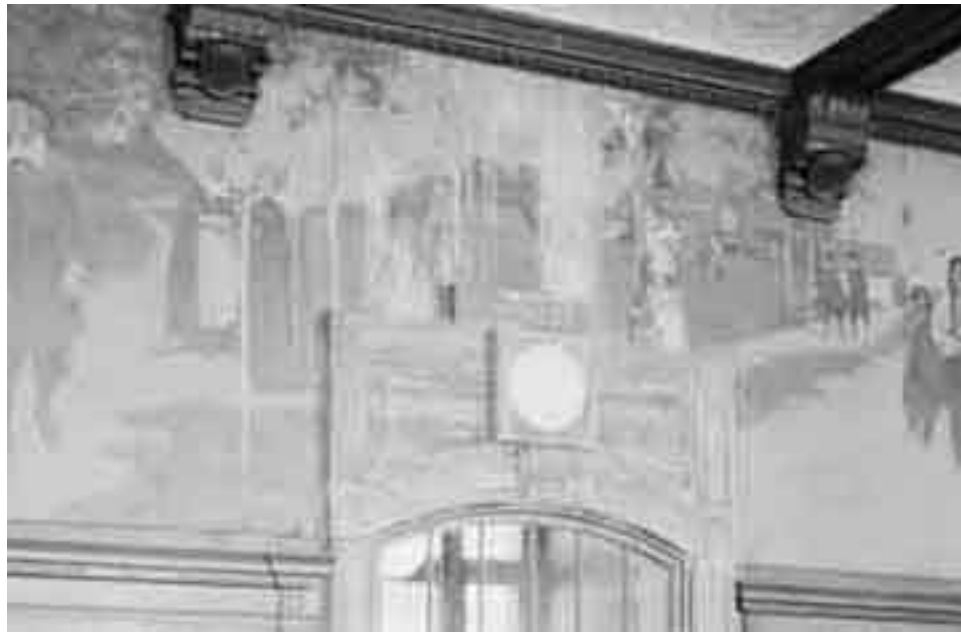
Archival photograph (detail) of water damage

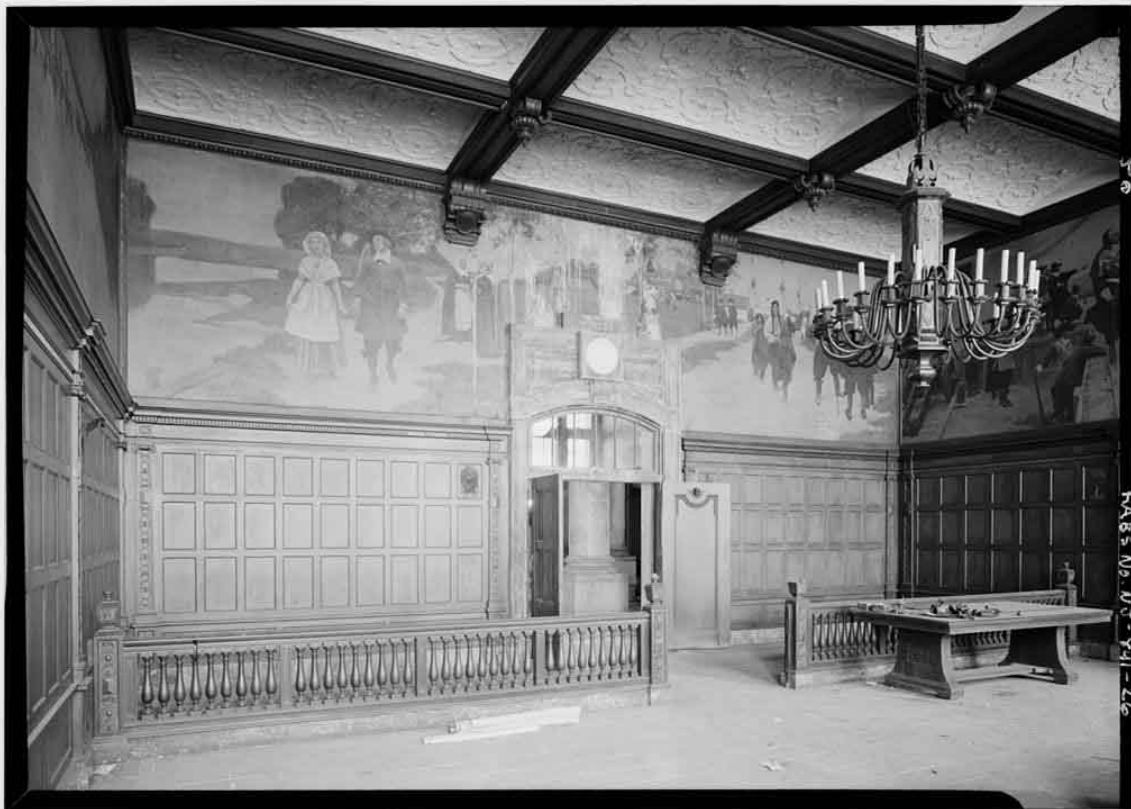
Archival photograph (overall) of water damage

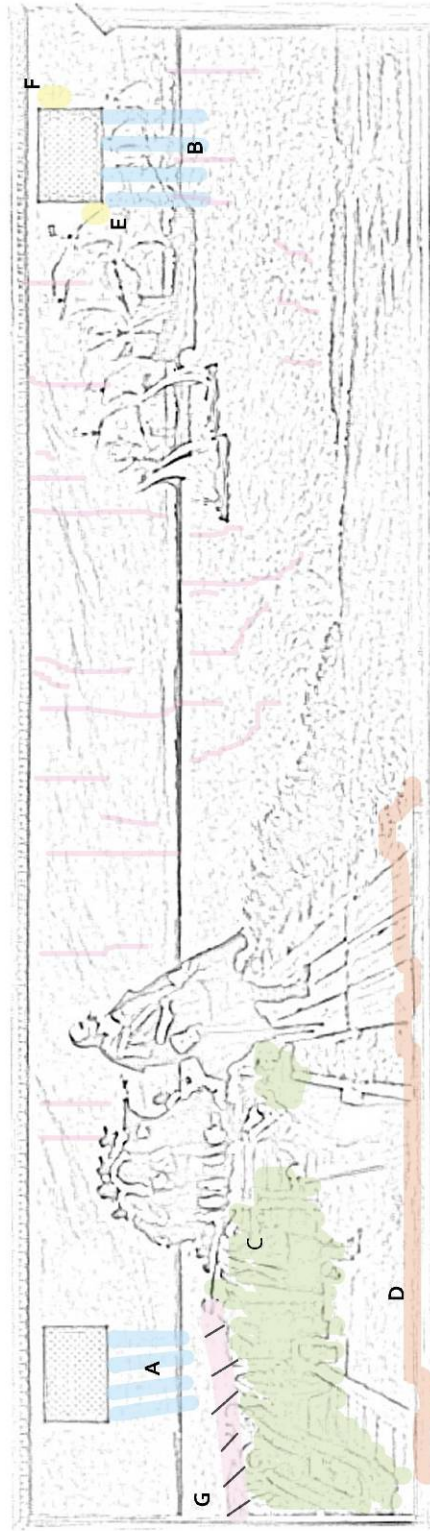
The Coming of the English
Howard Pyle
West Wall

Overall the paint appears relatively stable, with isolated exceptions of abraded paint along the lower horizontal border and actively cupping paint on the right side of the mural. There are areas of actively cupping paint that have a glossy sheen, probably due to the topical application of an adhesive. The paint is actively delaminating and requires further stabilization. There is vertical water staining below the two air vents and pinpoint paint loss around them.

Area A: left upper corner, vertical staining from air vent

Area B: right upper corner, vertical staining from air vent

Overall the mural does not seem to be heavily overpainted, though there is non-original paint covering drips and stains below the airvents.

Although the entire surface was not sounded due to limited access, a majority of the surface was assessed. Overall the plaster appears to be stable and in plane. There is linear staining

throughout the surface of the canvas, which appears to correlate with hairline plaster fissures. These are stable areas and characteristic of natural settling and aging.

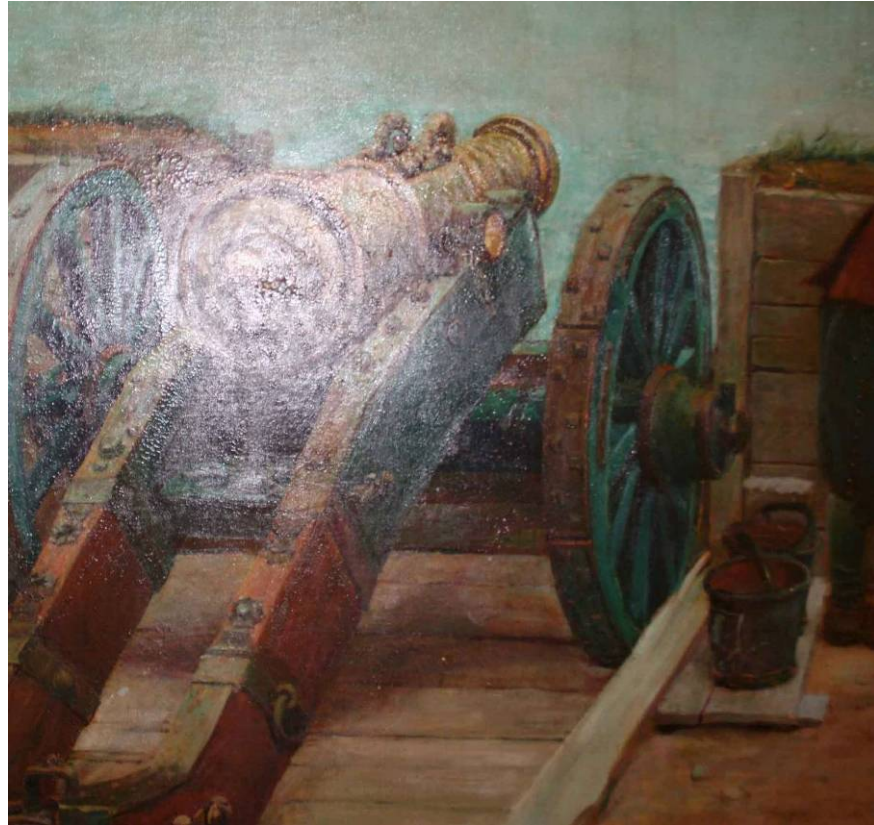
"The Coming of the English" Detail of Area C cupping paint

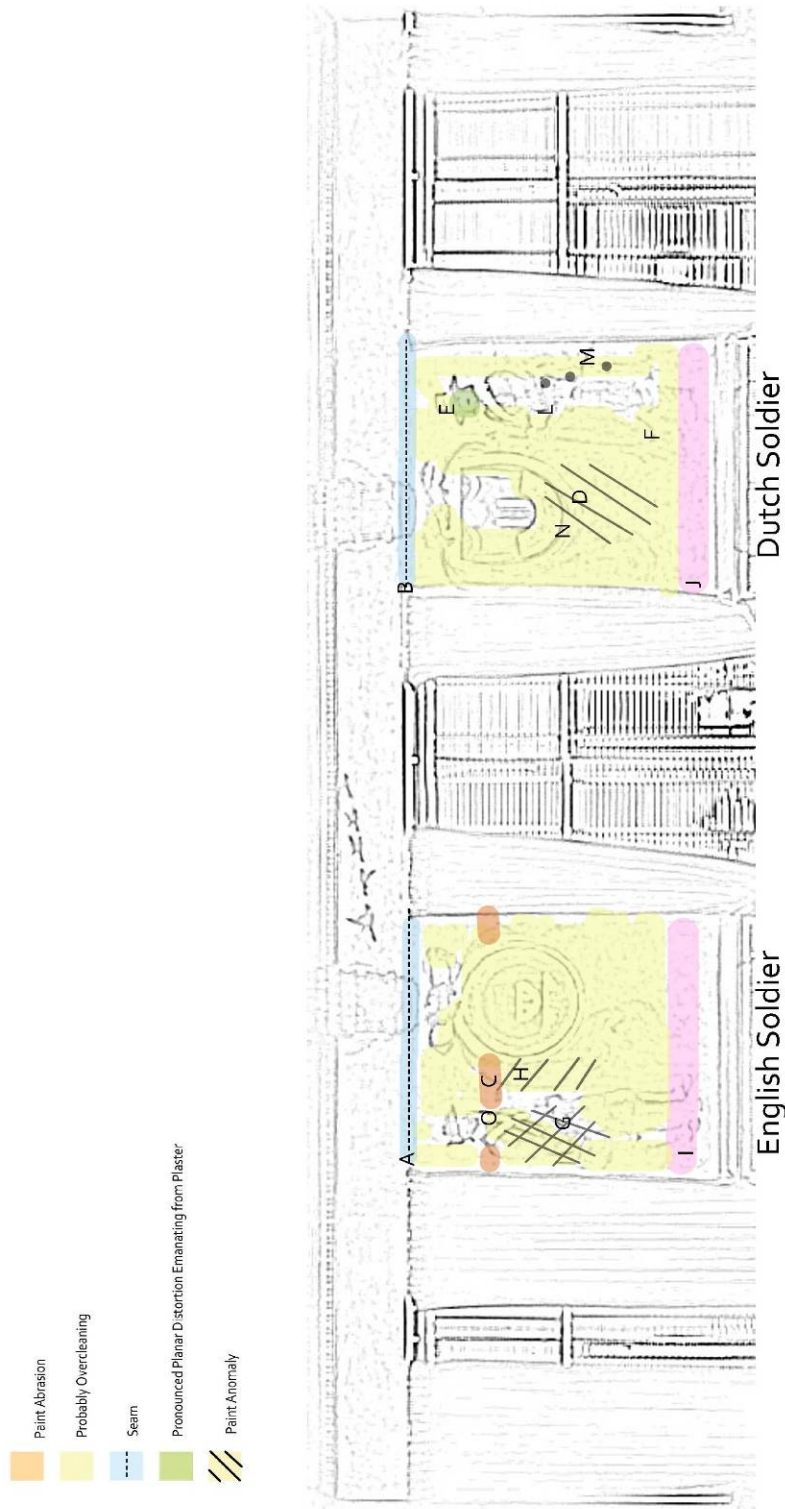
There is some staining on the surface that correlates to hairline fissures in the plaster

Area K: Three vertical hairline fissures in the plaster or canvas

Although the entire surface was not sounded due to limited access the plaster appears to be stable and in plane.

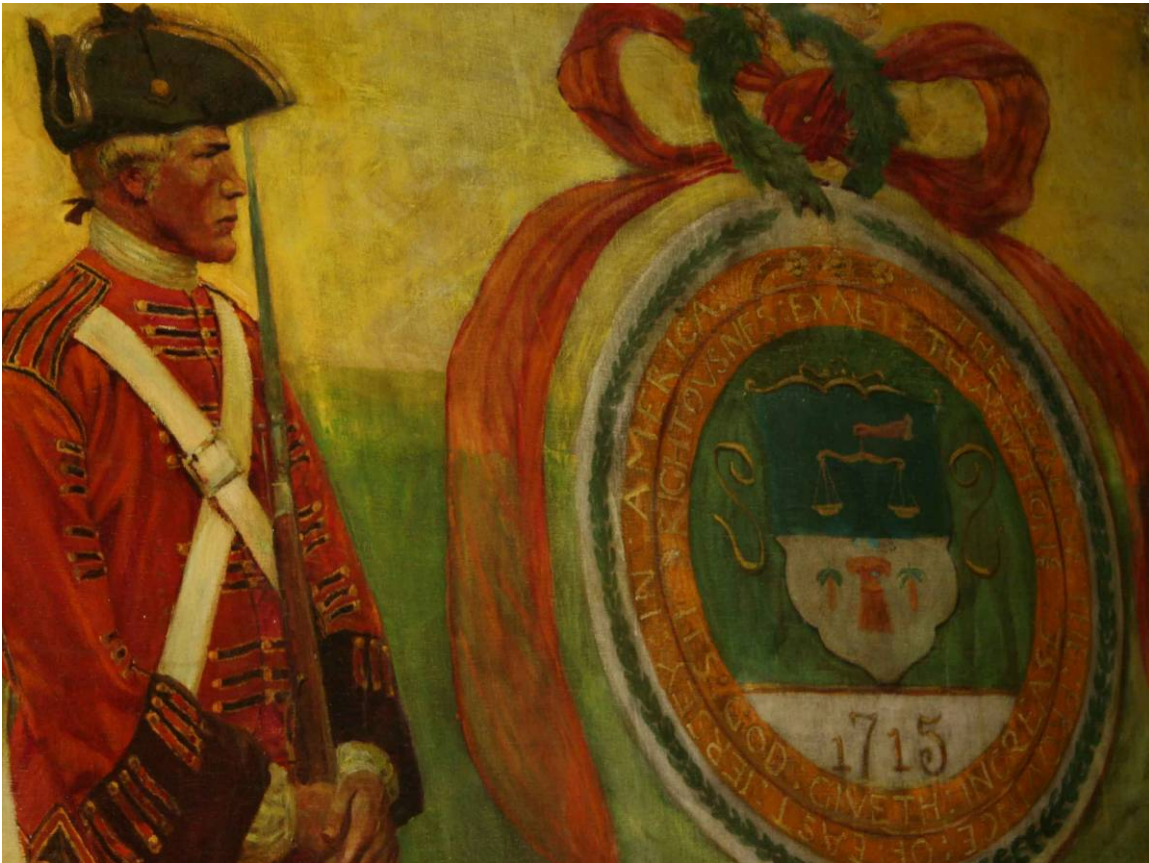
"English Soldier" Detail of Area C paint abrasion

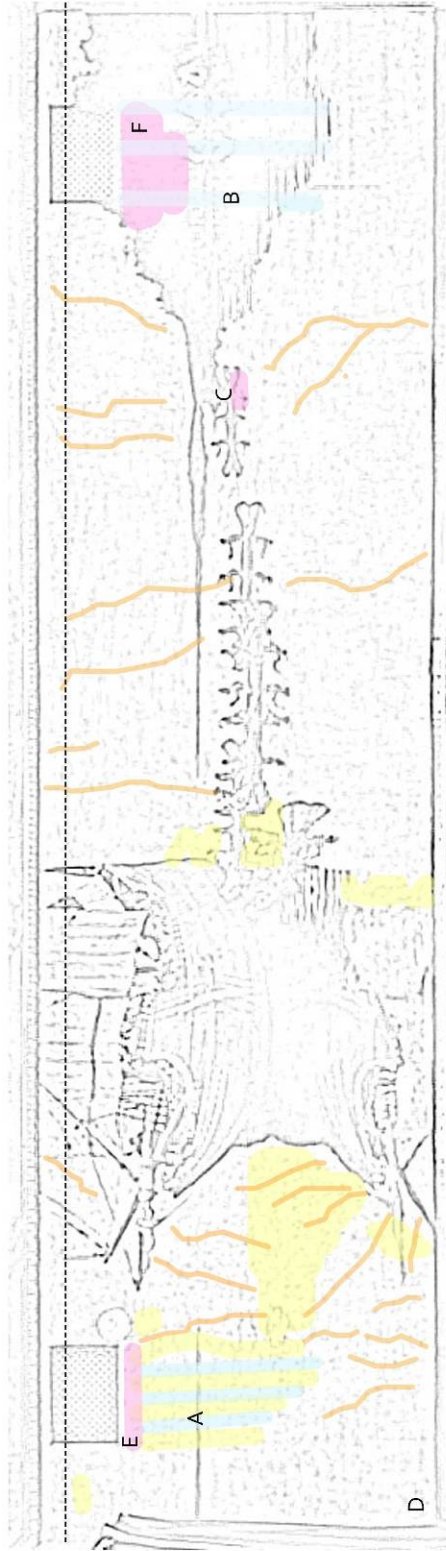
Henry Hudson and the Half-Moon
Howard Pyle
East Wall

Although the entire surface was not sounded due to limited access the plaster appears to be stable and in plane. There are vertical crack patterns that have stained the canvas, emanating from hairline fissures in the plaster; however, these appear to be stable.

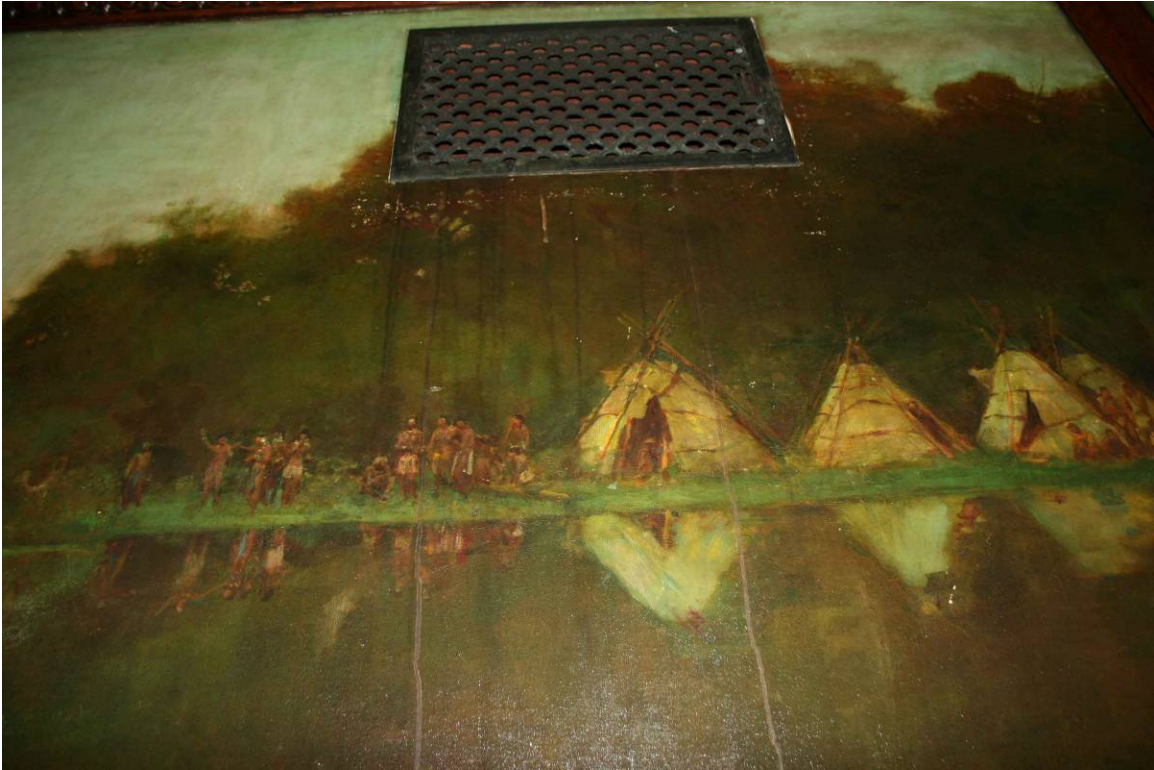
"Hendryk Hudson and the Half-Moon" Detail of water stains and paint loss

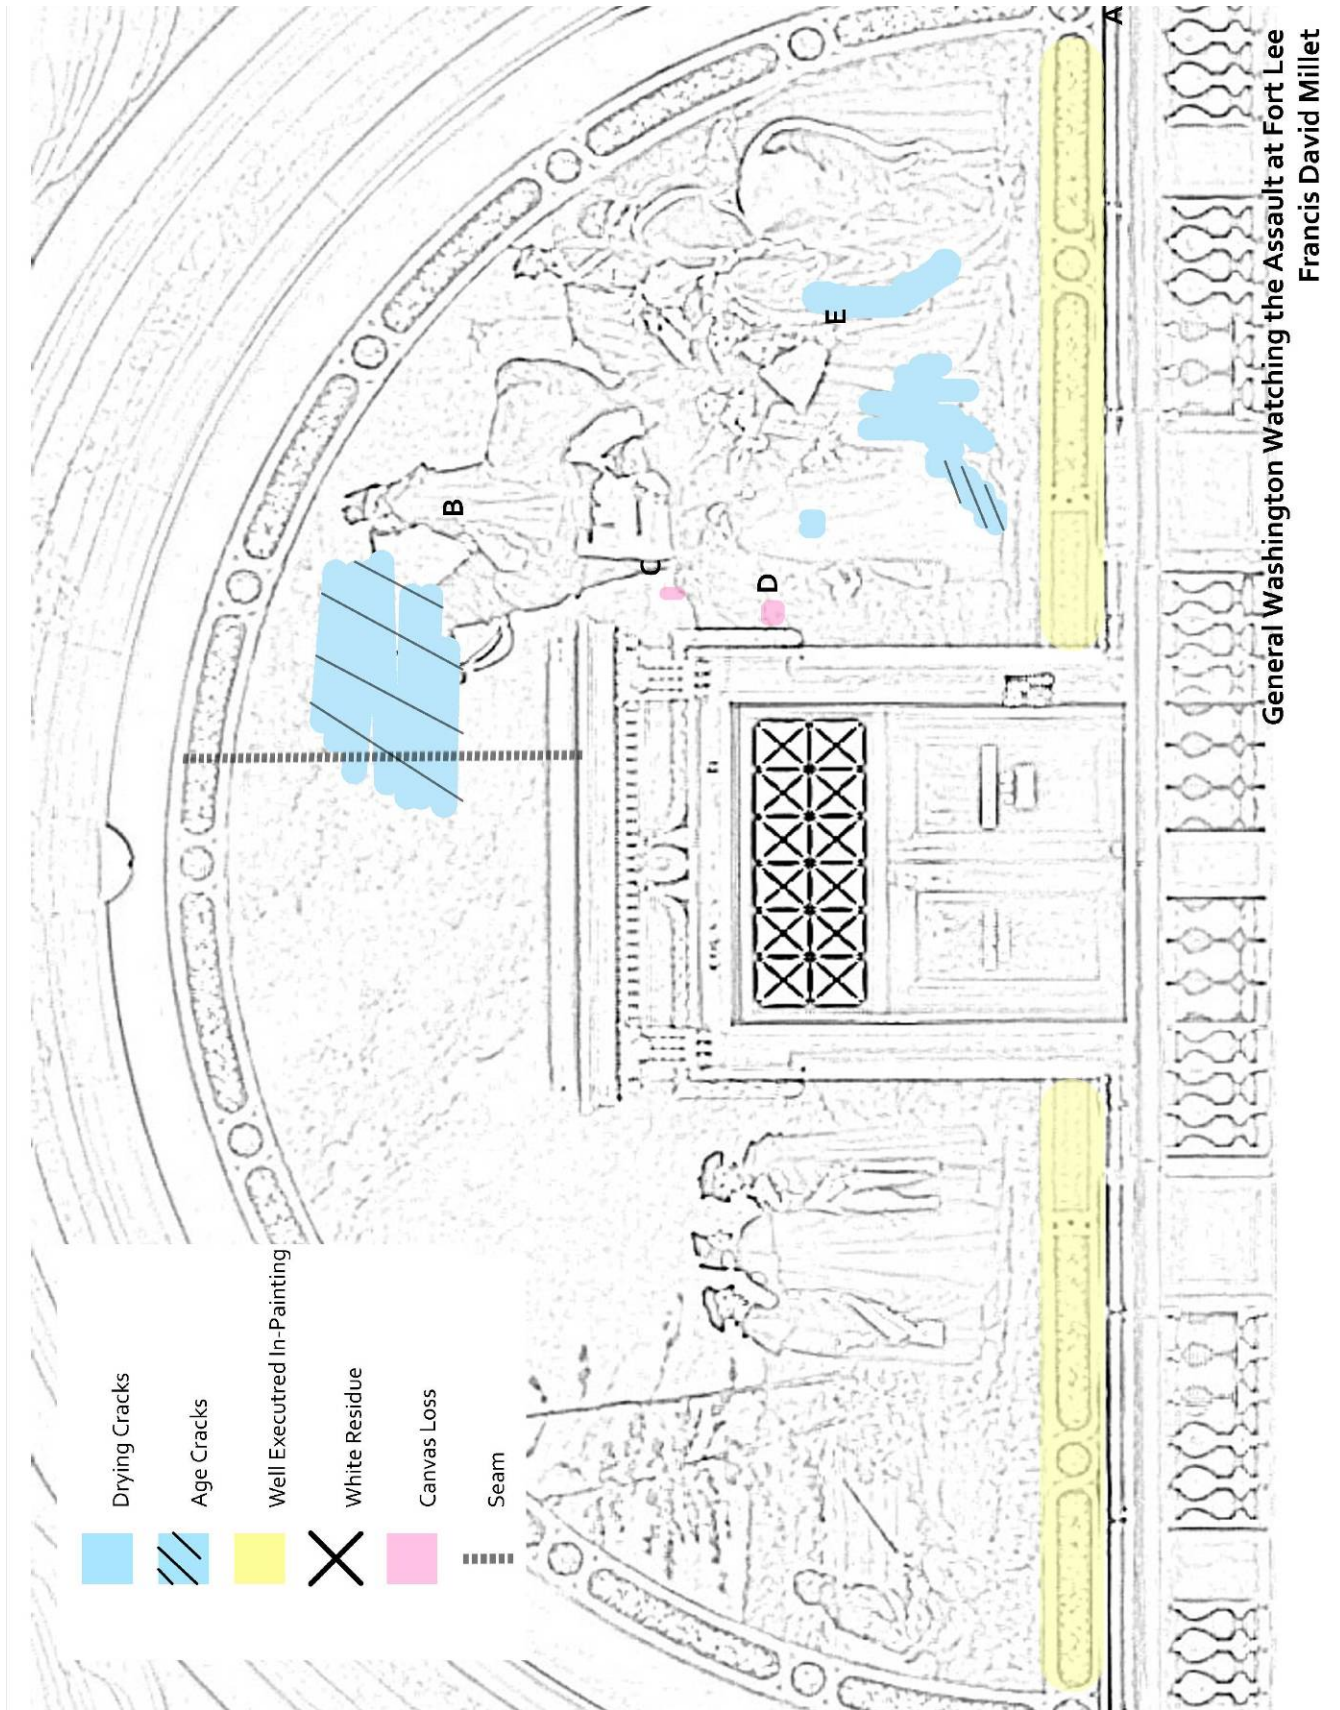
General Washington Watching the Assault at Fort Lee
Francis David Millet

The lower horizontal decorative border has a fair amount of inpainting that is well executed, visible only in ultraviolet light. This area has more abrasion and pinpoint paint loss due to the location, affected by pedestrian traffic and cleaning of the brass railing.

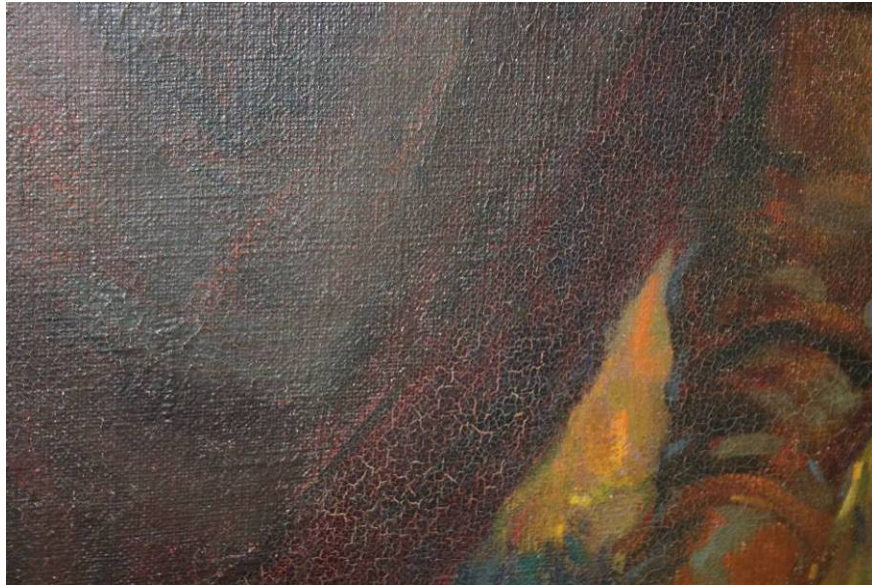
Figure 2. "General Washington at Fort Lee..." Detail of drying cracks

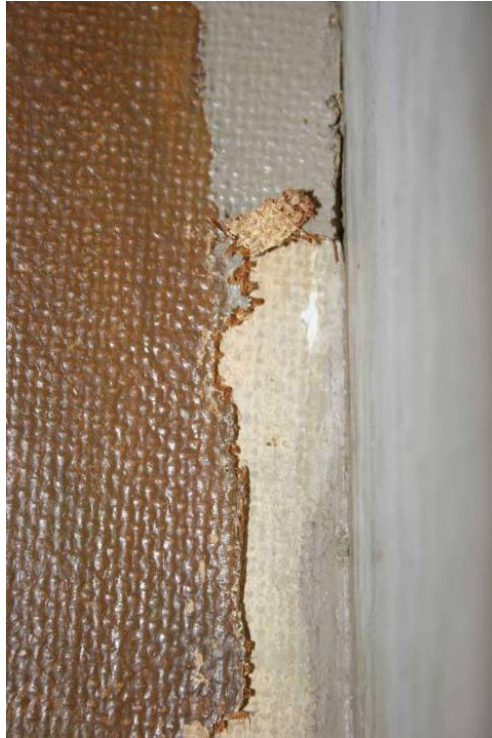
Figure 3. "General Washington at Fort Lee..." Detail of canvas loss and underlying canvas

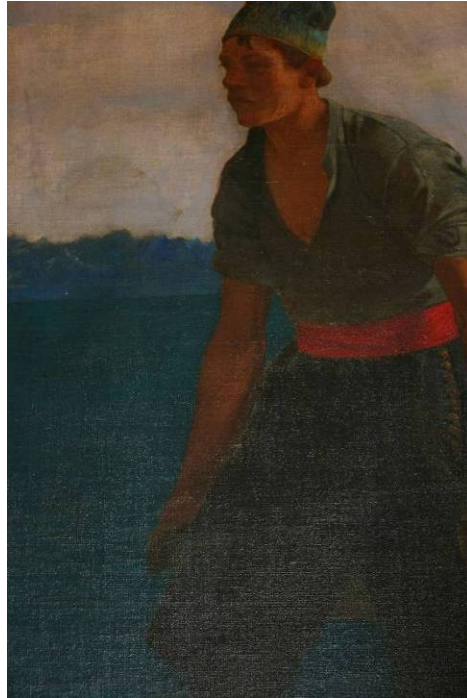
"Paying for the Land" Area A, Discoloration, upper left
