***Hudson County Courthouse
Murals and Historic Finishes Investigation
Jersey City, New Jersey***

May 25, 2012

Written by:
Gillian Randell & Amanda Stauffer,
Conservators
EverGreene Architectural Arts,
450 West 31st Street, 7th Floor
New York, NY 10001
T: (212) 244-2800
Submitted by:
Bill Mensching, Project Manager

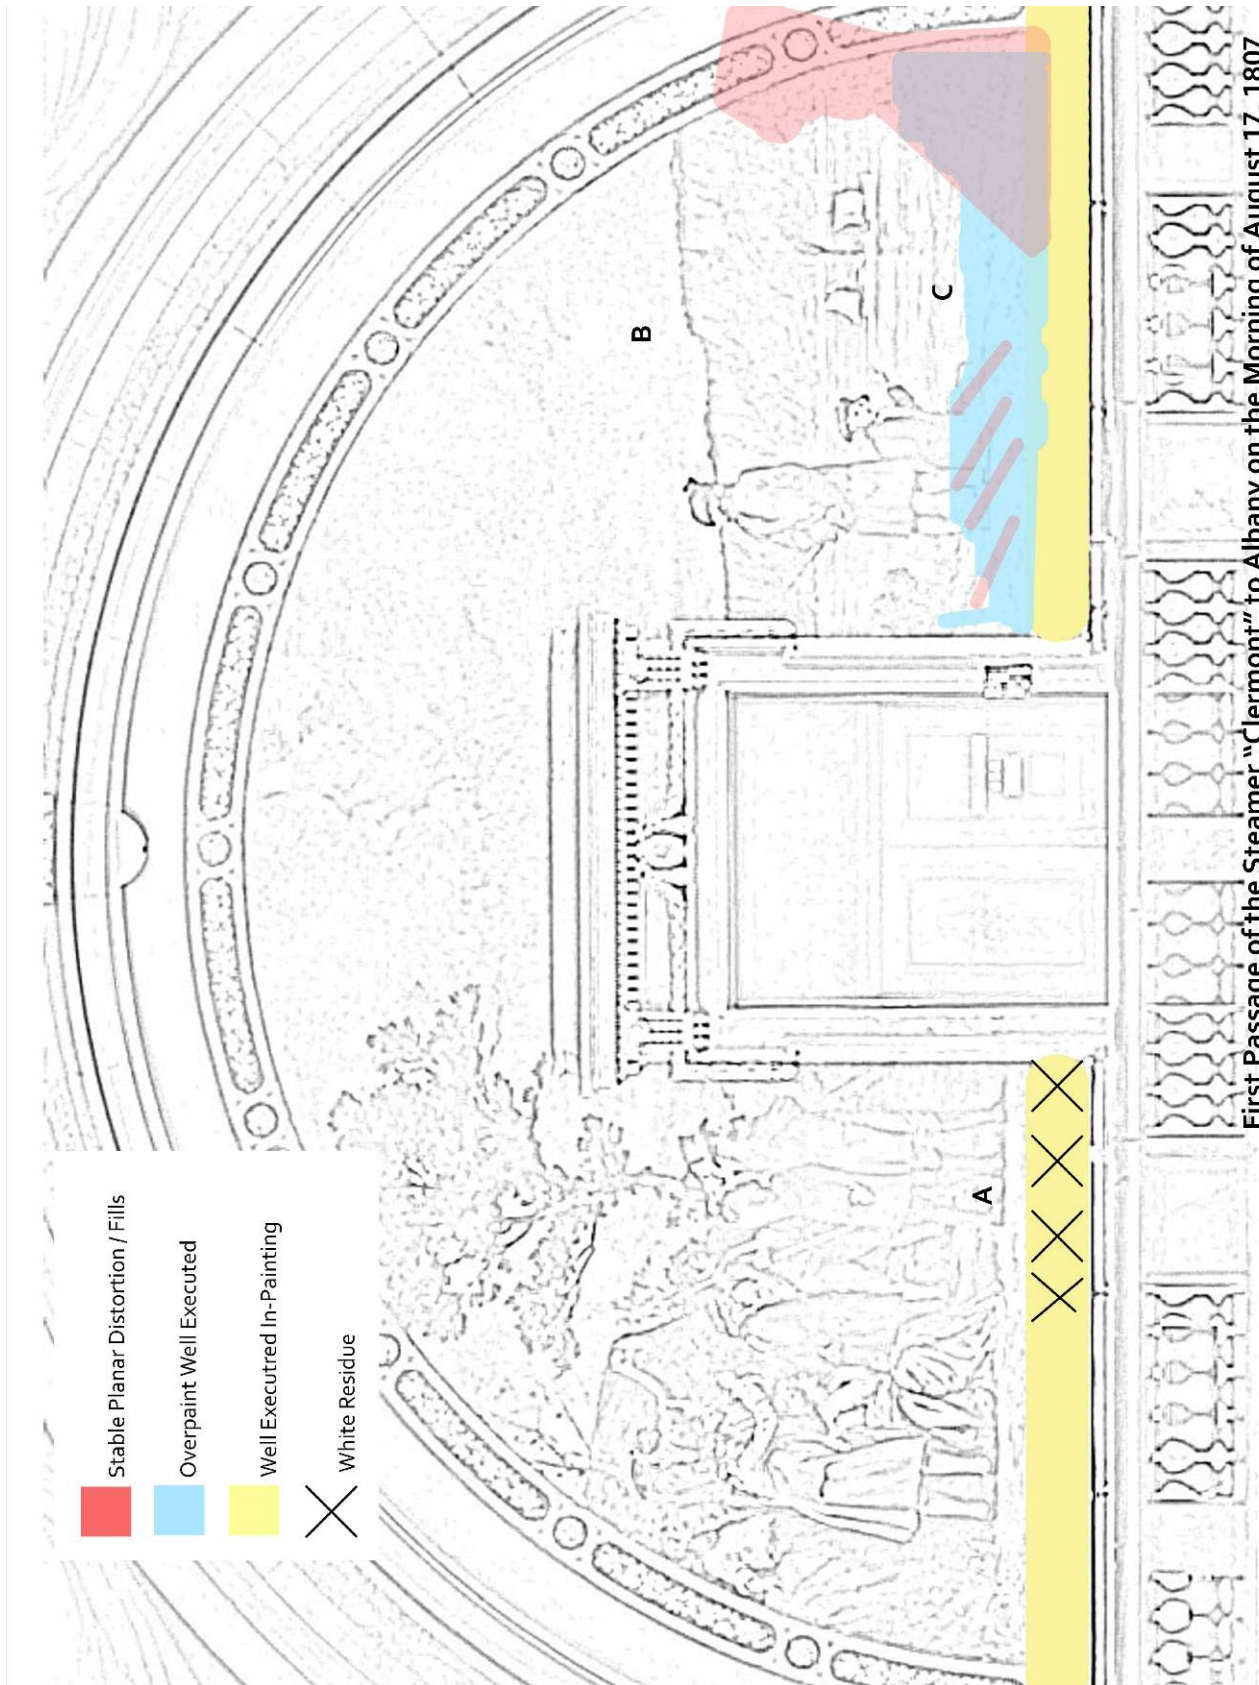
First Passage of the Steamer "Clermont" to Albany on the Morning of August 17, 1807
Charler Yardley Turner

Archival photographs show that this portion of canvas was removed and reattached, probably during the 1975-1985 restoration period. Although extensive, the inpainting is well executed.

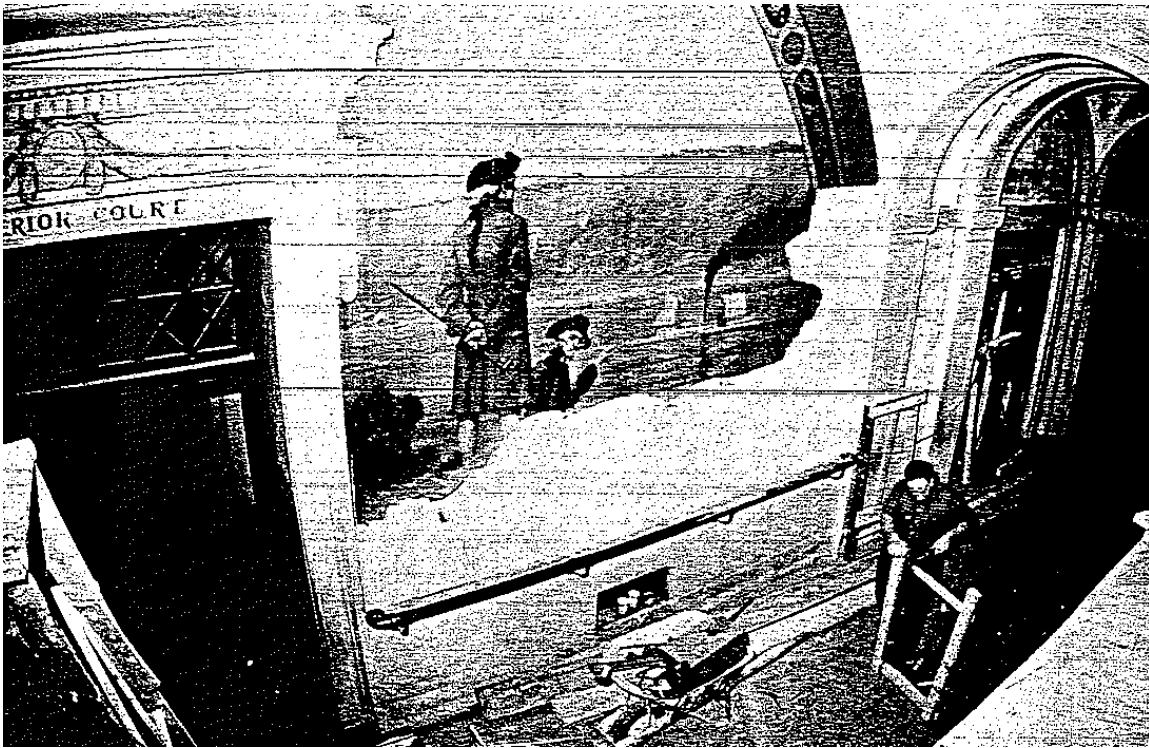
1970s photograph showing large-scale loss in the "First Passage..." mural

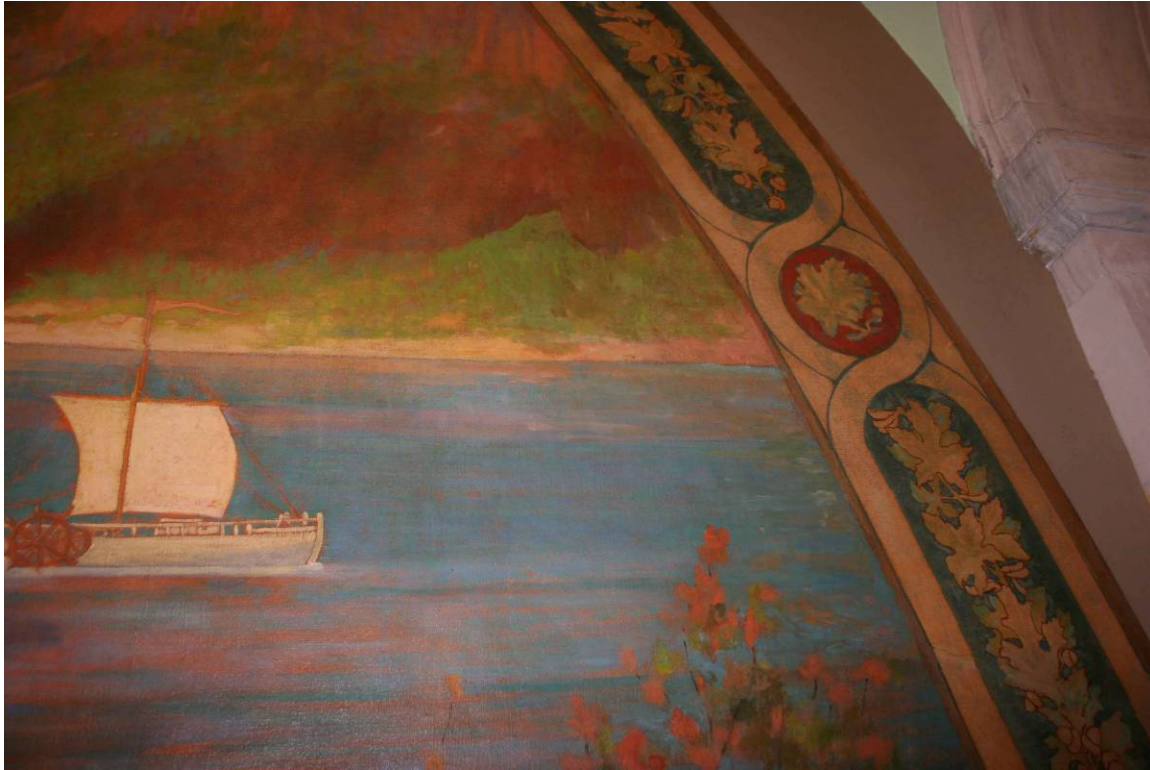
"First Passage of the Steamer Clermont..." Area C Overpaint

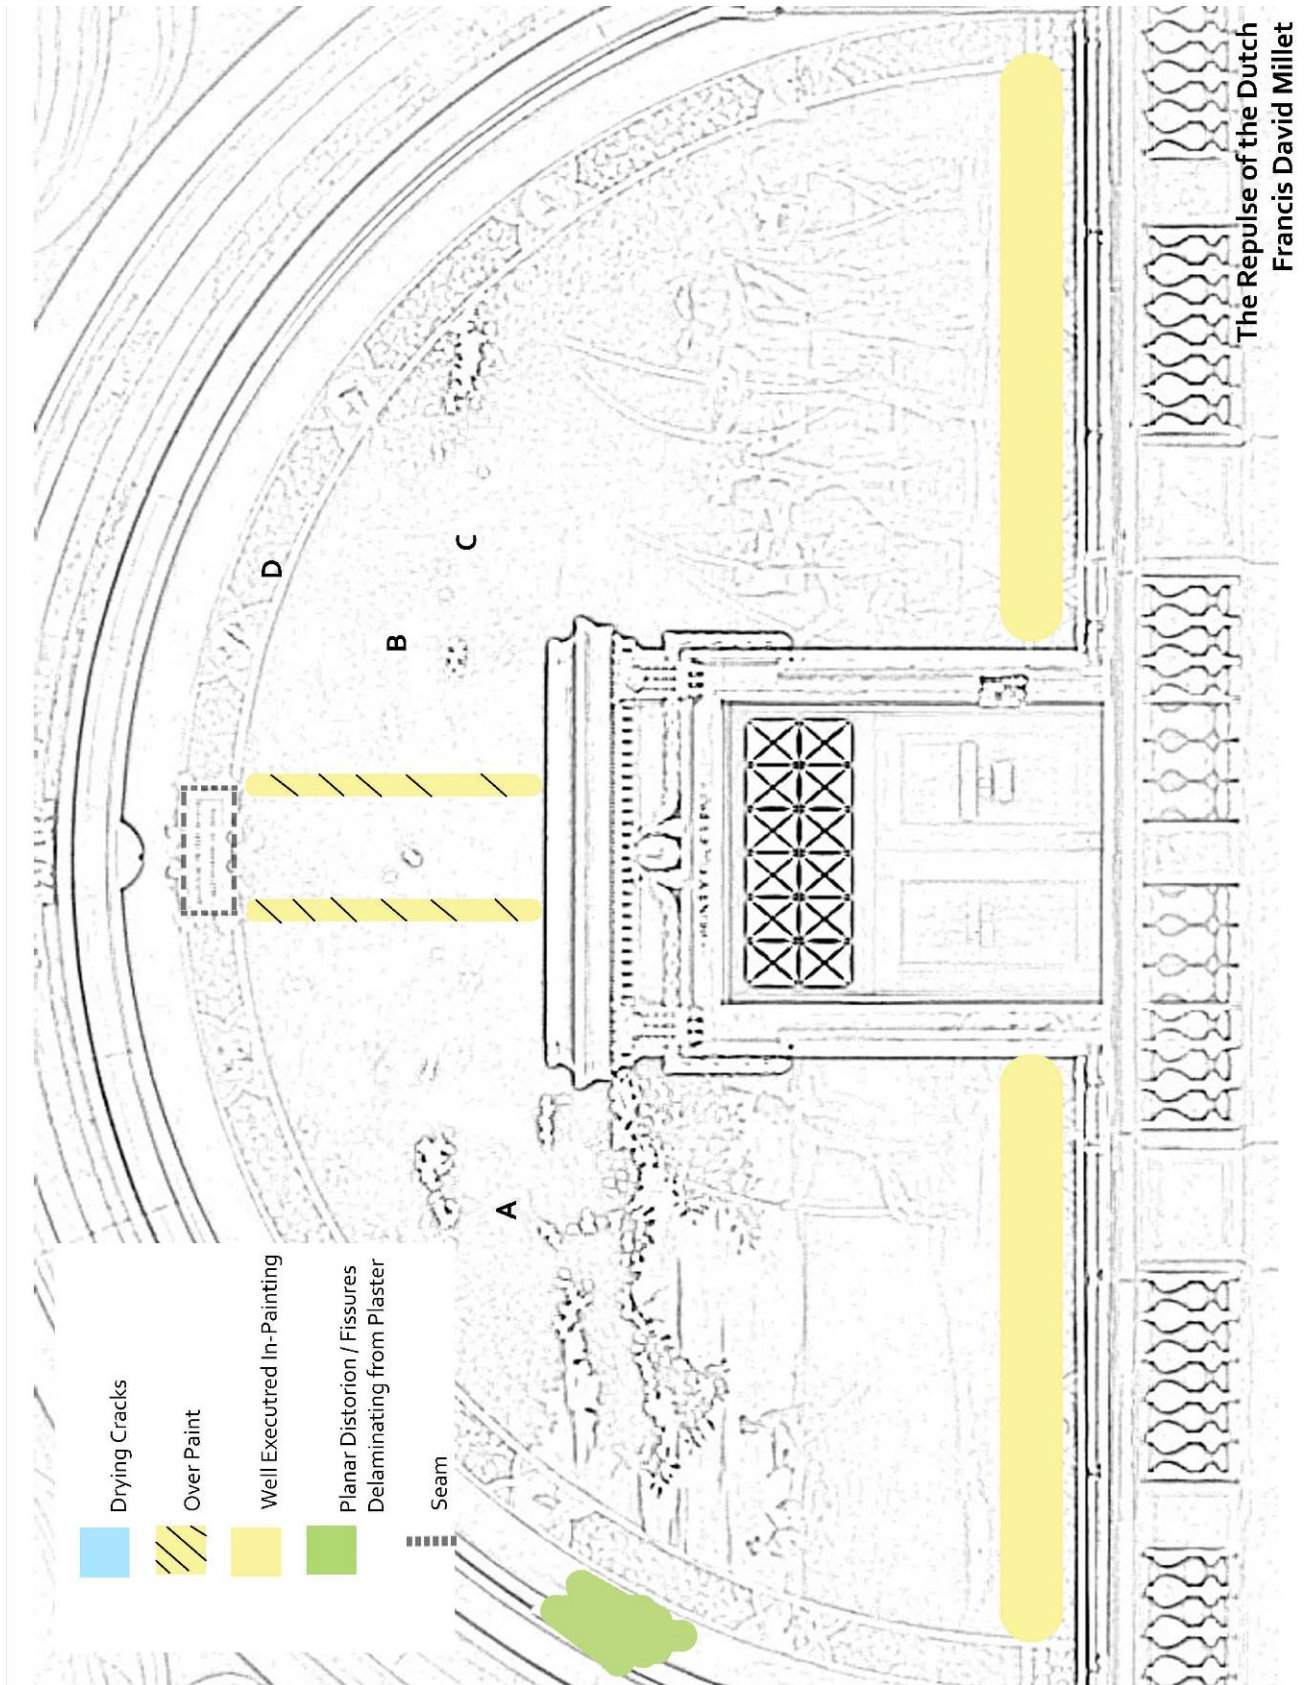
The Repulse of the Dutch
Francis David Millet

The ceiling above the mural has evidence of mold, which may or may not be active, probably associated with water damage.

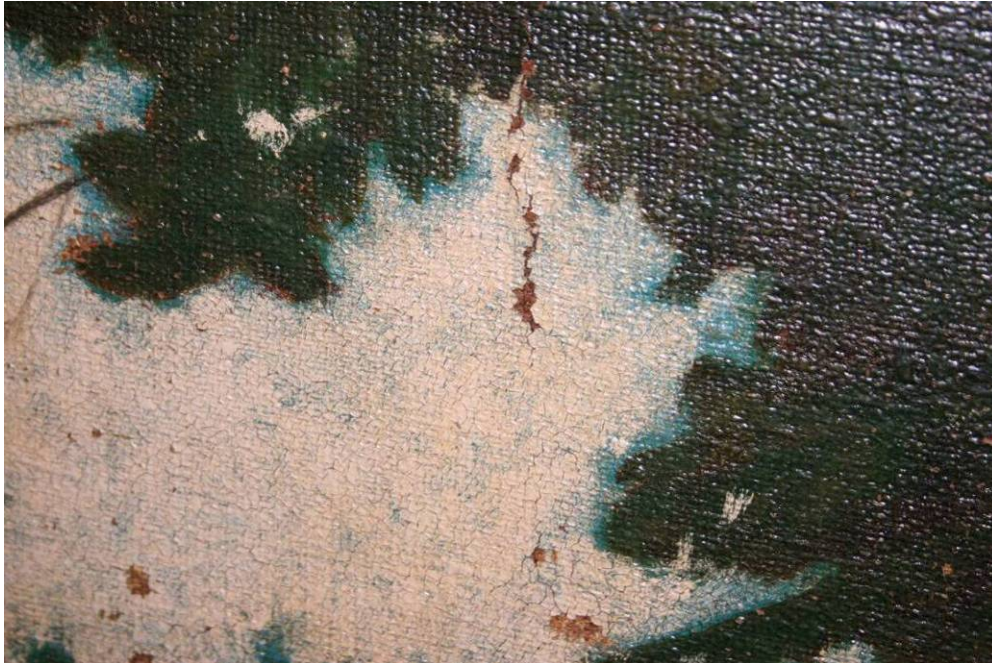
"Repulse of the Dutch" Area A, upper left pinpoint paint loss

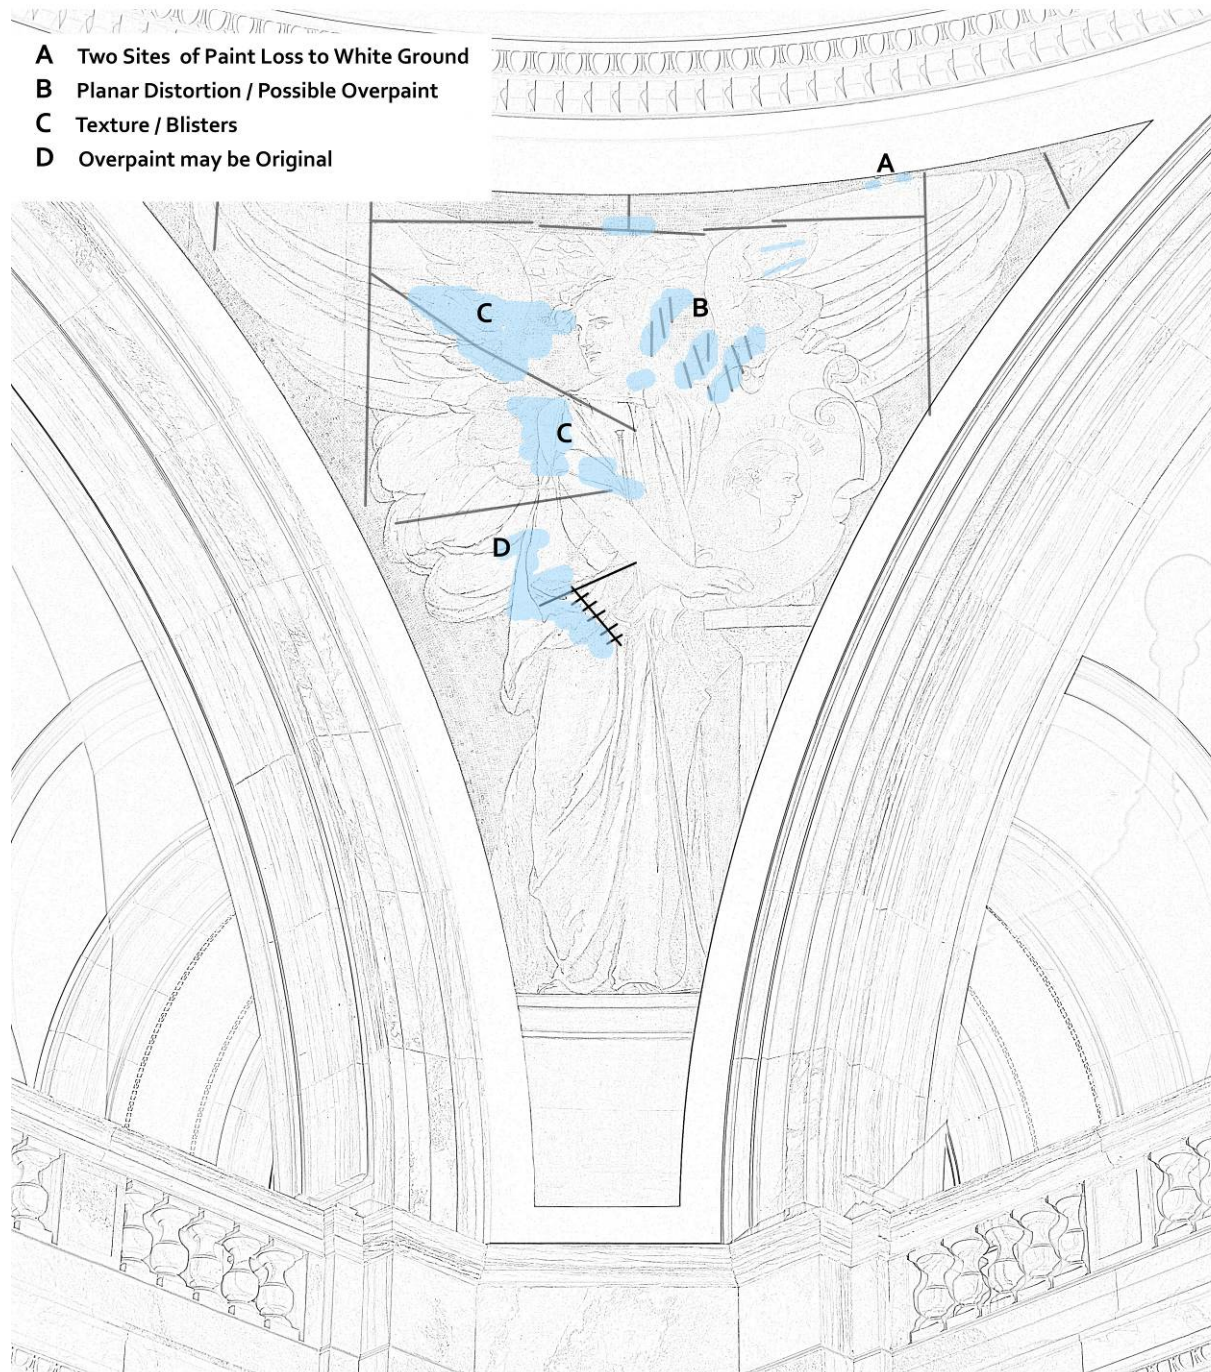
- A Two Sites of Paint Loss to White Ground
- B Planar Distortion / Possible Overpaint
- C Texture / Blisters
- D Overpaint may be Original

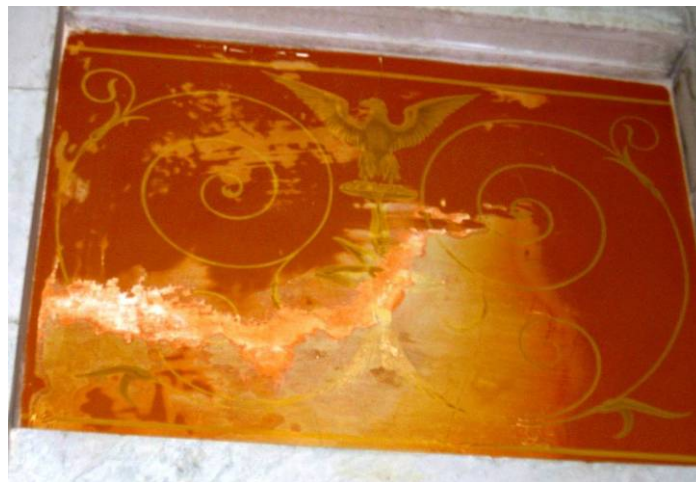
Water damage, staining and efflorescence at the second floor frieze (SE corner)

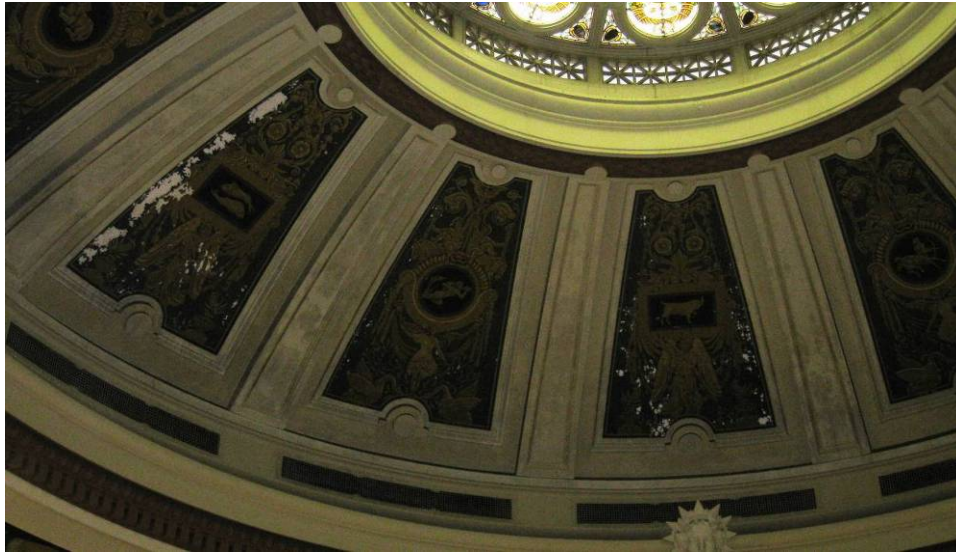
Flaking and loss at the dome ceiling

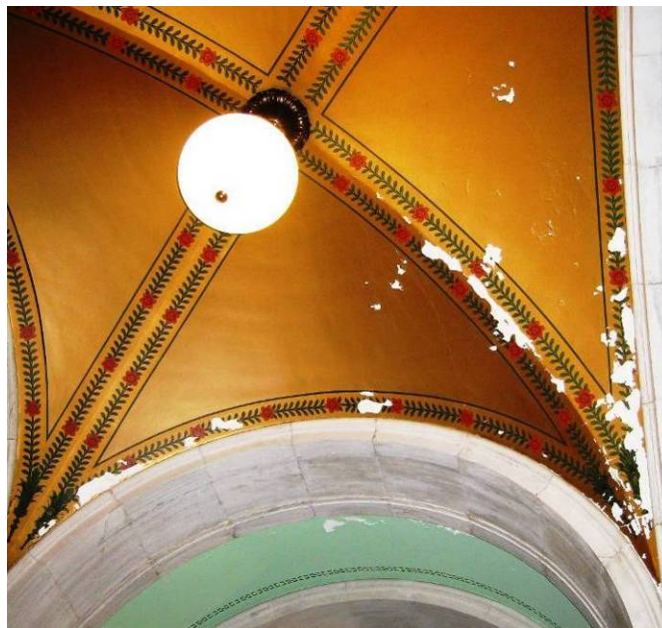
Water damage and paint loss at the 4th floor southeast corner
