EVERGREENE
Architectural Arts

**WILLIAM J. BRENNAN COURTHOUSE
(HUDSON COUNTY COURTHOUSE)
PHASE II MURAL CONSERVATION: ROTUNDA DOME
JERSEY CITY, NEW JERSEY**

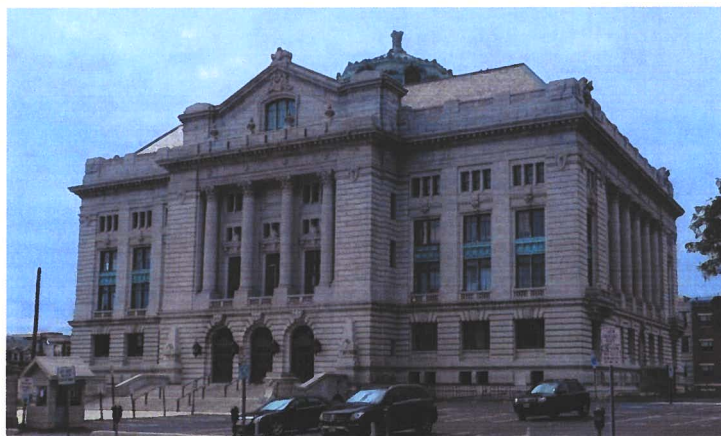
Figure 1. September 2018 view of the Brennan Courthouse. (Image by Jim Henderson, Own work, CC BY-SA 4.0)

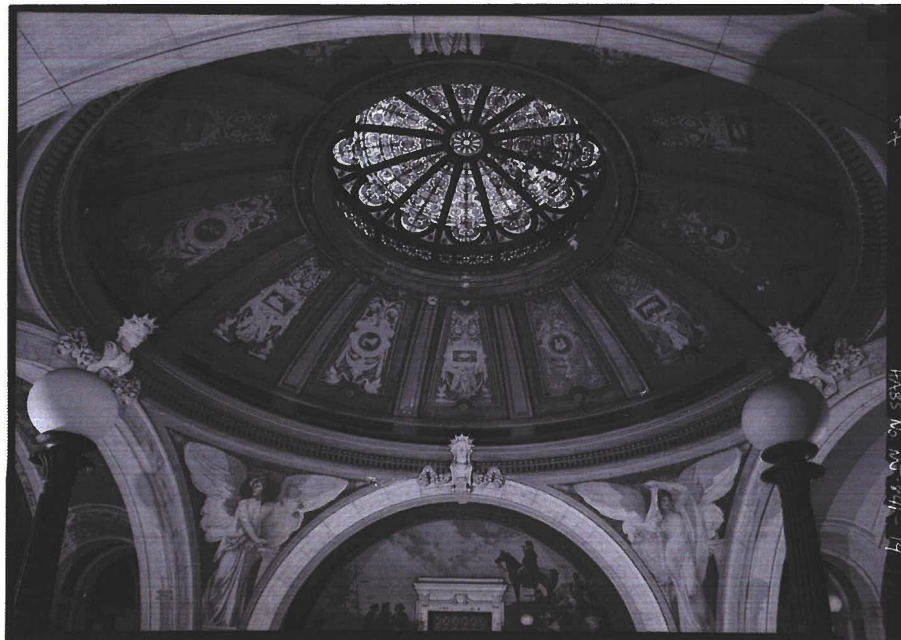
Figure 2. March 1979 view of the rotunda and fourth floor pendentives and lunette, before restoration. (Photo by Jack Boucher, Historic American Buildings Survey)

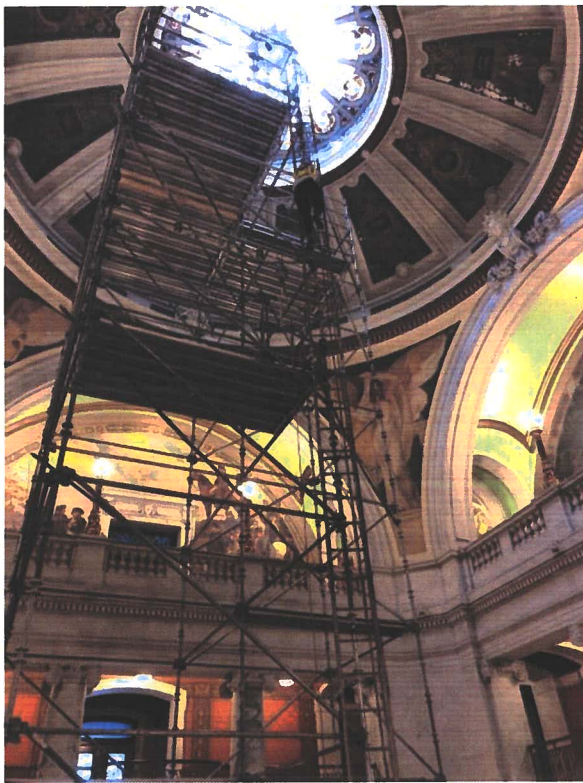
Figure 4. Initially, ceiling panels were accessed with a mobile scaffold tower. (Photo by EverGreene, June 2020)

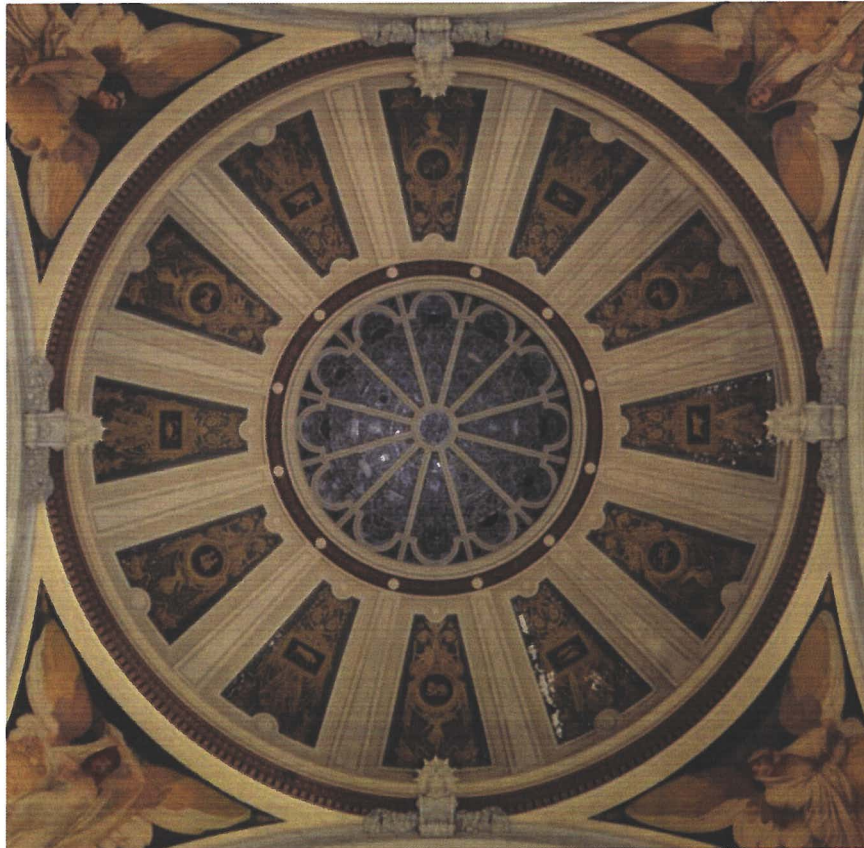
Figure 6. 2016 view of the rotunda ceiling and Zodiac panels, before treatment. (Photo by Whitney Cox, September 2016)

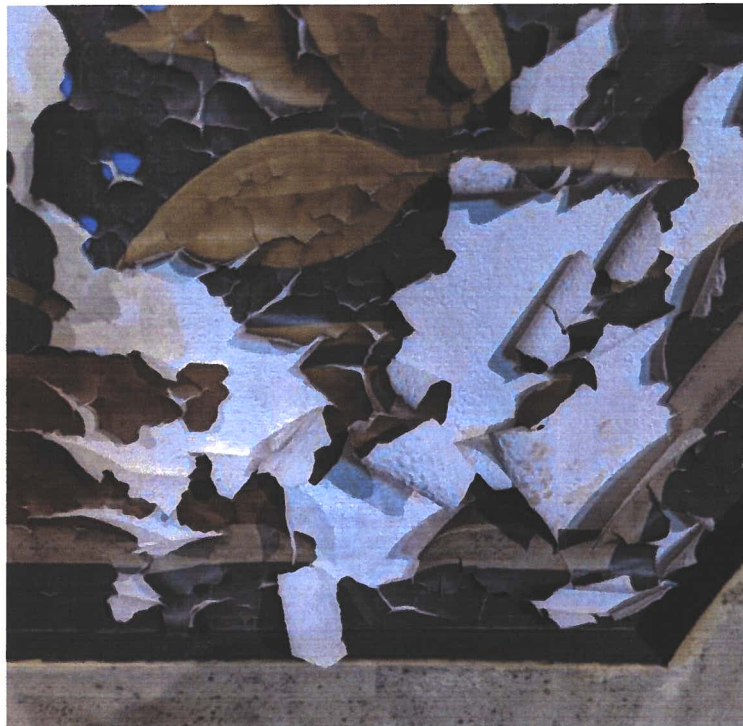
Figure 7. Detail of severe paint detachment and curling at "Capricorn" panel.
(Photo by EverGreene, July 2020)

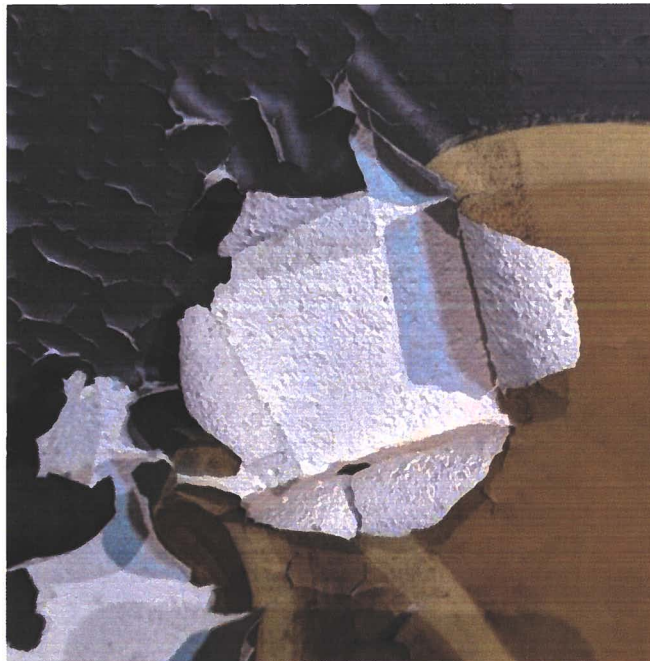
Figure 8. Detail of plaster deterioration (efflorescence and chalking) at "Capricorn" panel. (Photo by EverGreene, July 2020)

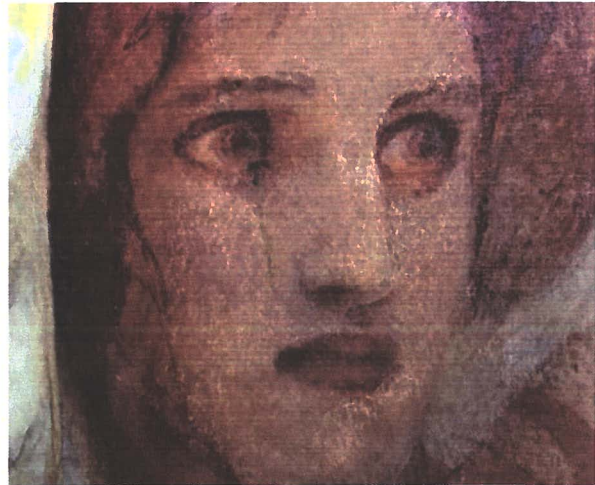
Figure 10. Detail of thin paint layer and exposed ground layer. (Photo by EverGreene, August 2020)

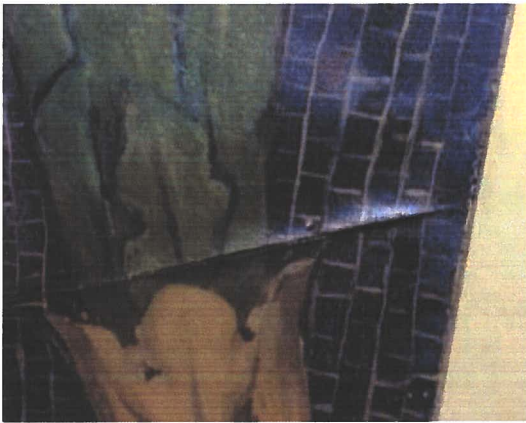
Figure 12. Detail of canvas detachment and lifting. (Photo by EverGreene, August 2020)

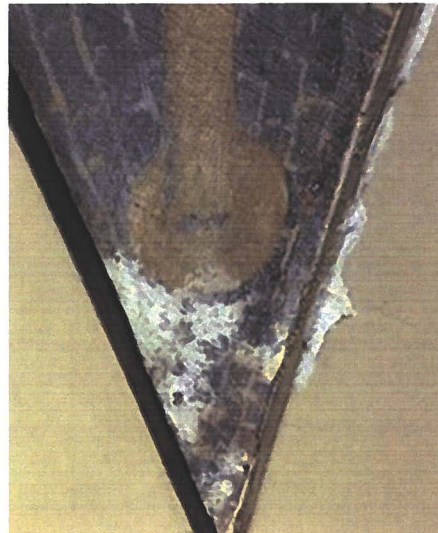
Figure 14. Detail of water damage and efflorescence at mural and adjacent plaster molding. (Photo by EverGreene, August 2020)

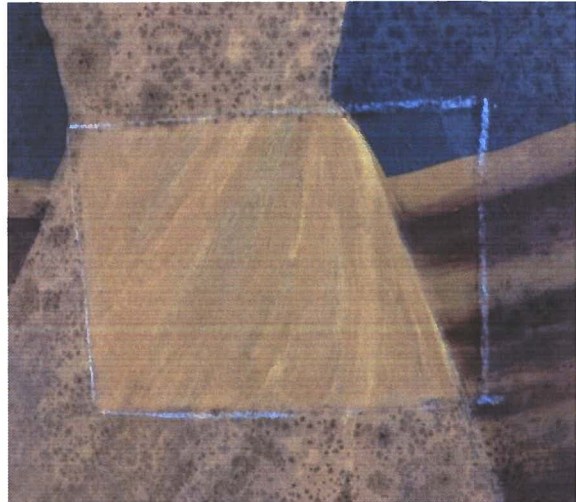
Figure 15. Detail of surface cleaning testing on "Leo" zodiac panel. (Photo by EverGreene, June 2020)

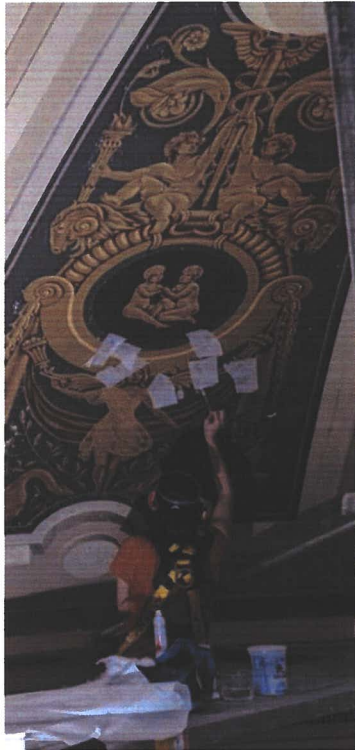
Figure 22. Ongoing paint consolidation on "Libra" panel. (Photo by EverGreene, July 2020)
