***Hudson County Courthouse
Murals and Historic Finishes Investigation
Jersey City, New Jersey***

May 25, 2012

Written by:
Gillian Randell & Amanda Stauffer,
Conservators
EverGreene Architectural Arts,
450 West 31st Street, 7th Floor
New York, NY 10001
T: (212) 244-2800
Submitted by:
Bill Mensching, Project Manager

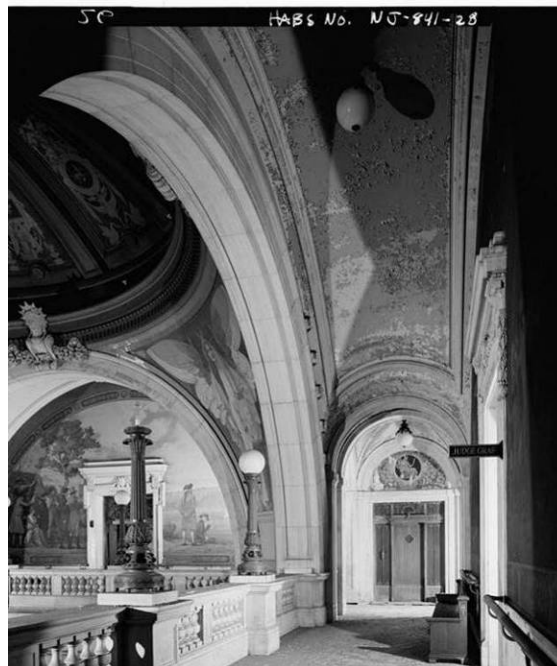
Vast areas of water damage and flaking paint, as captured in the above HABS photograph, would have necessitated the scraping and skimming

of the plaster surface in order to promote adhesion with repainting media.

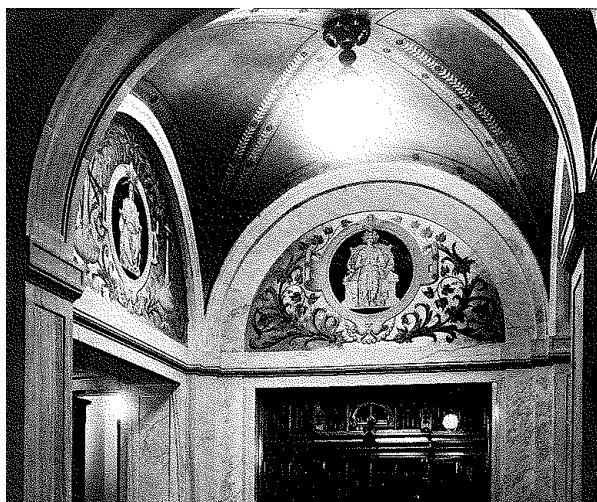
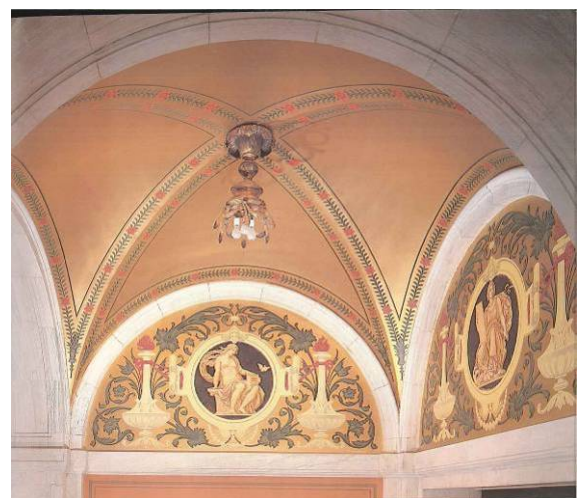
Photograph of the fourth floor groin vaults and lunettes, c. 1910 (left) and restored, c. 1975 (right)

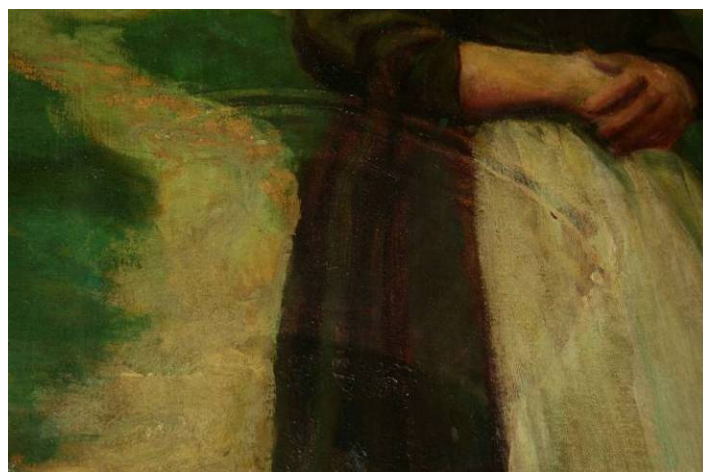
"Life in an Old Dutch Town" Detail of Area E, pentimenti

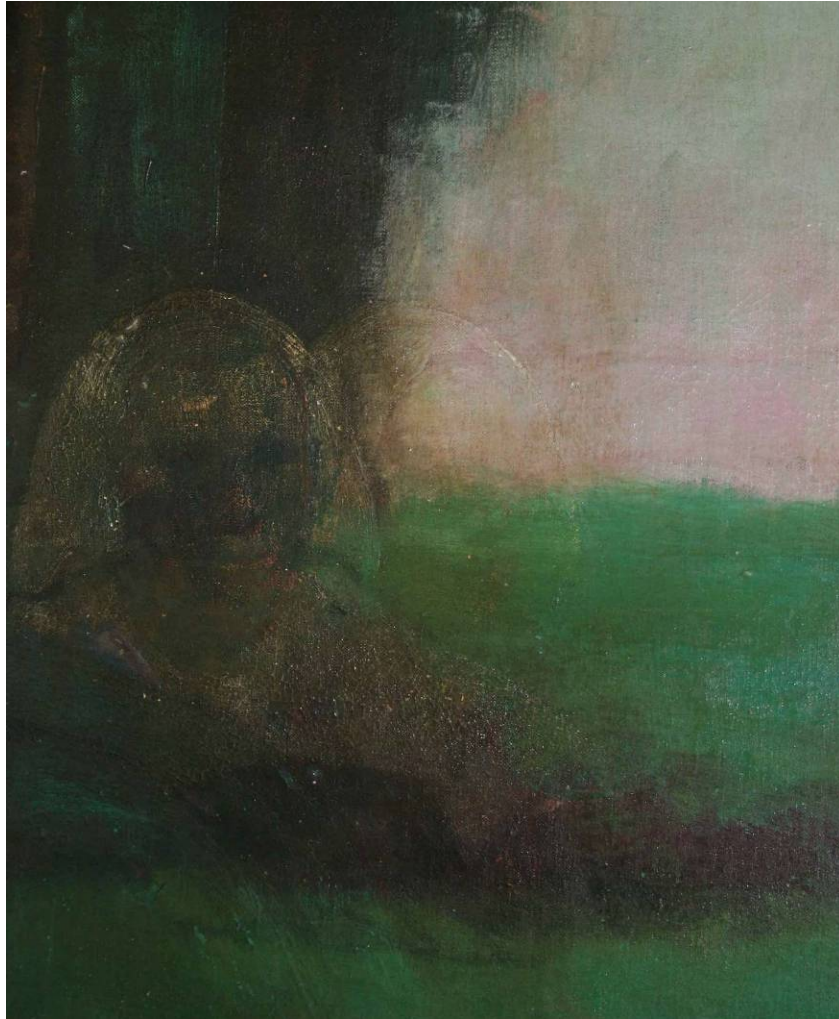
"Life in an Old Dutch Town" Detail of Area G, pentimenti

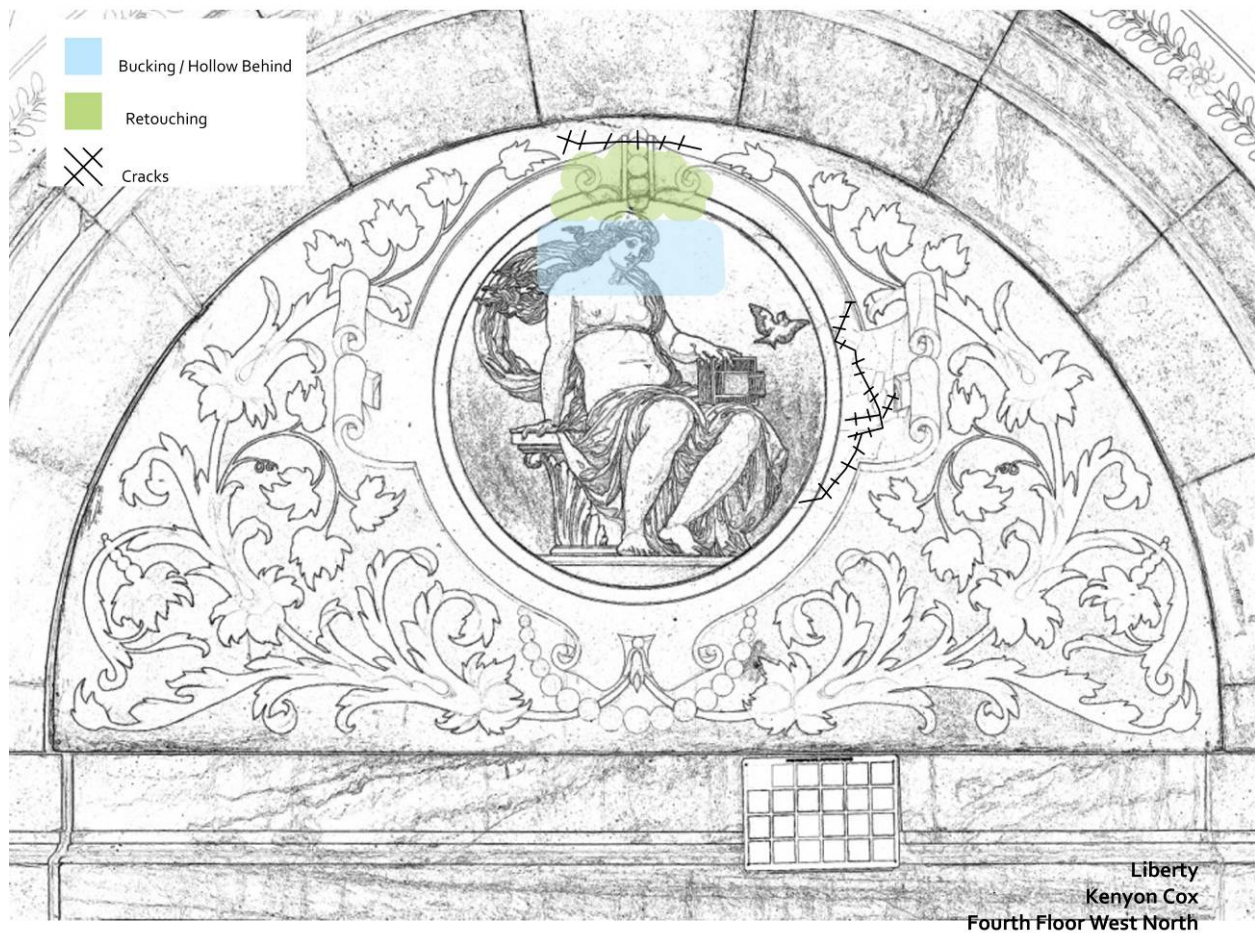
The canvas appears well adhered to the plaster and in plane. A network of cracks, including several prominent cracks, appear in the plaster directly to the right of the canvas. A large crack runs through the plaster above the medallion, directly above an area that sounds hollow and may be structurally compromised behind the canvas. The fact that this area has been heavily retouched suggests that it may have been previously damaged by water infiltration.

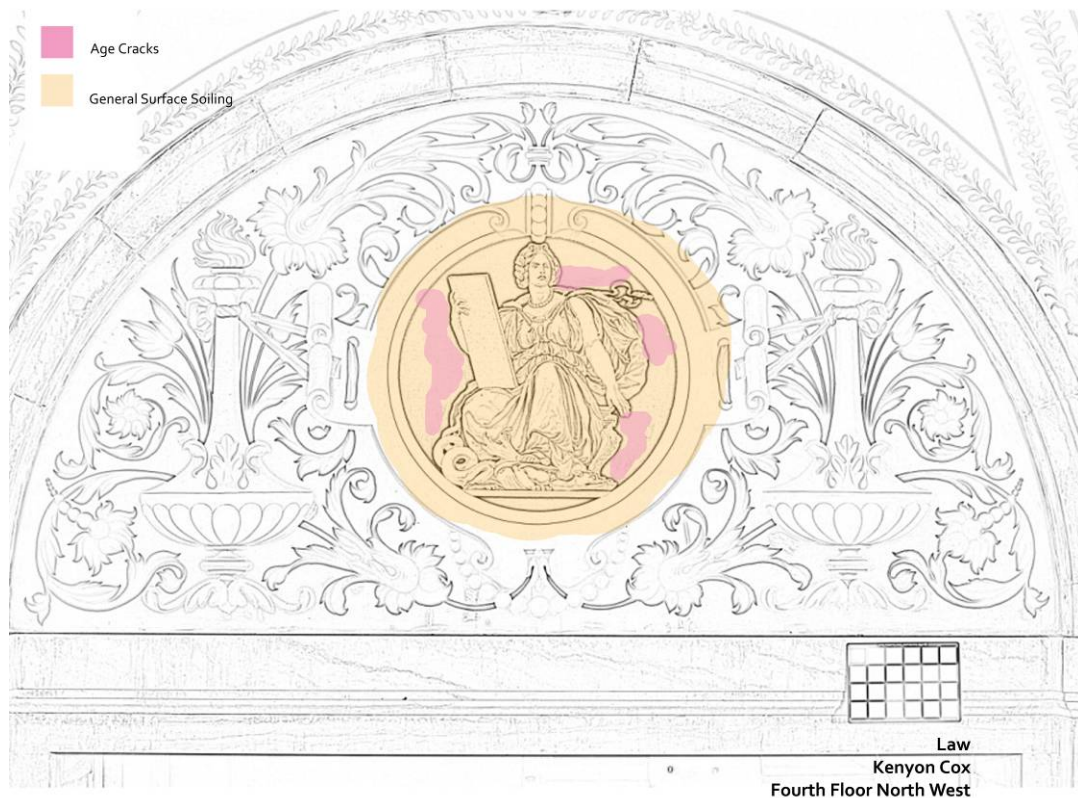
The canvas appears well adhered to the plaster and in plane.

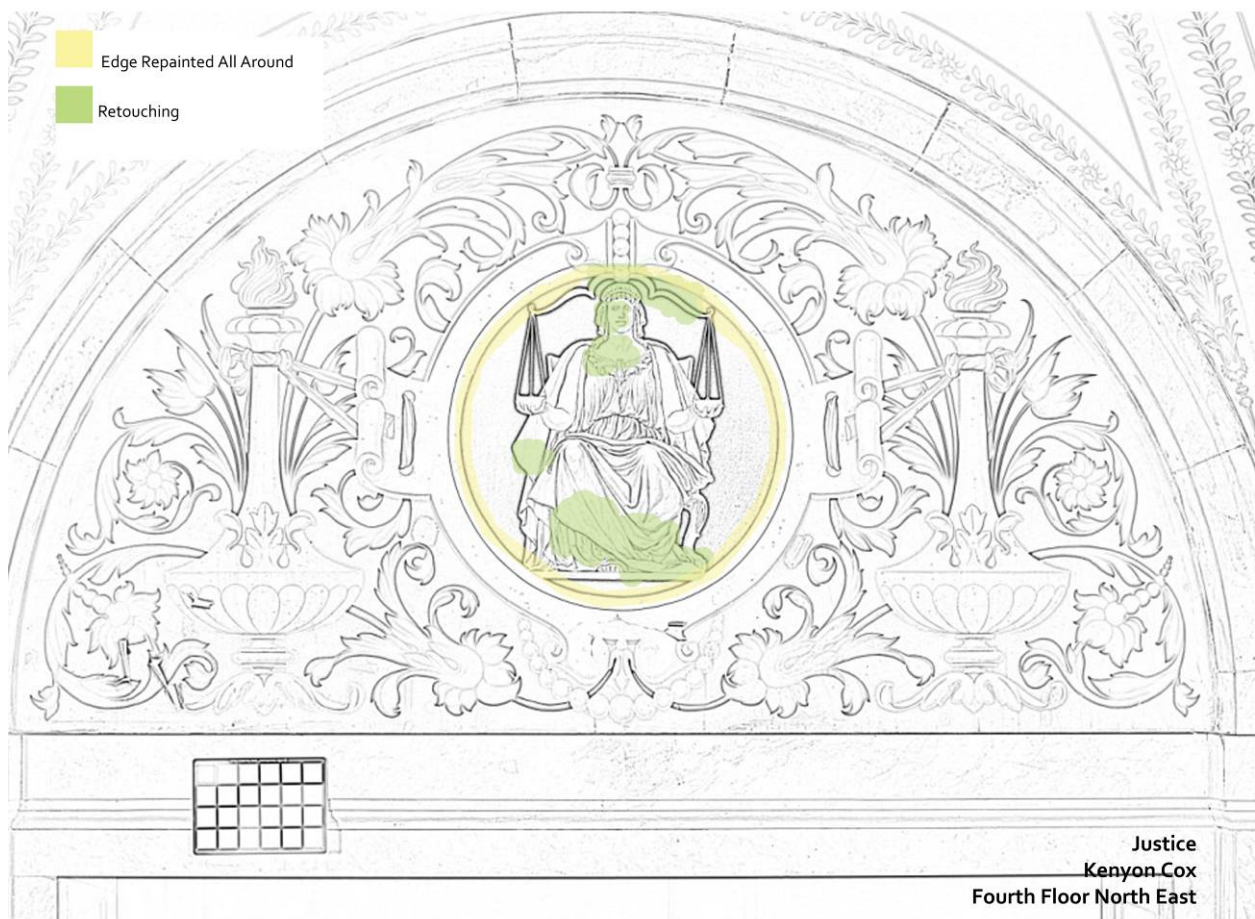
The canvas appears well adhered to the plaster and in plane.

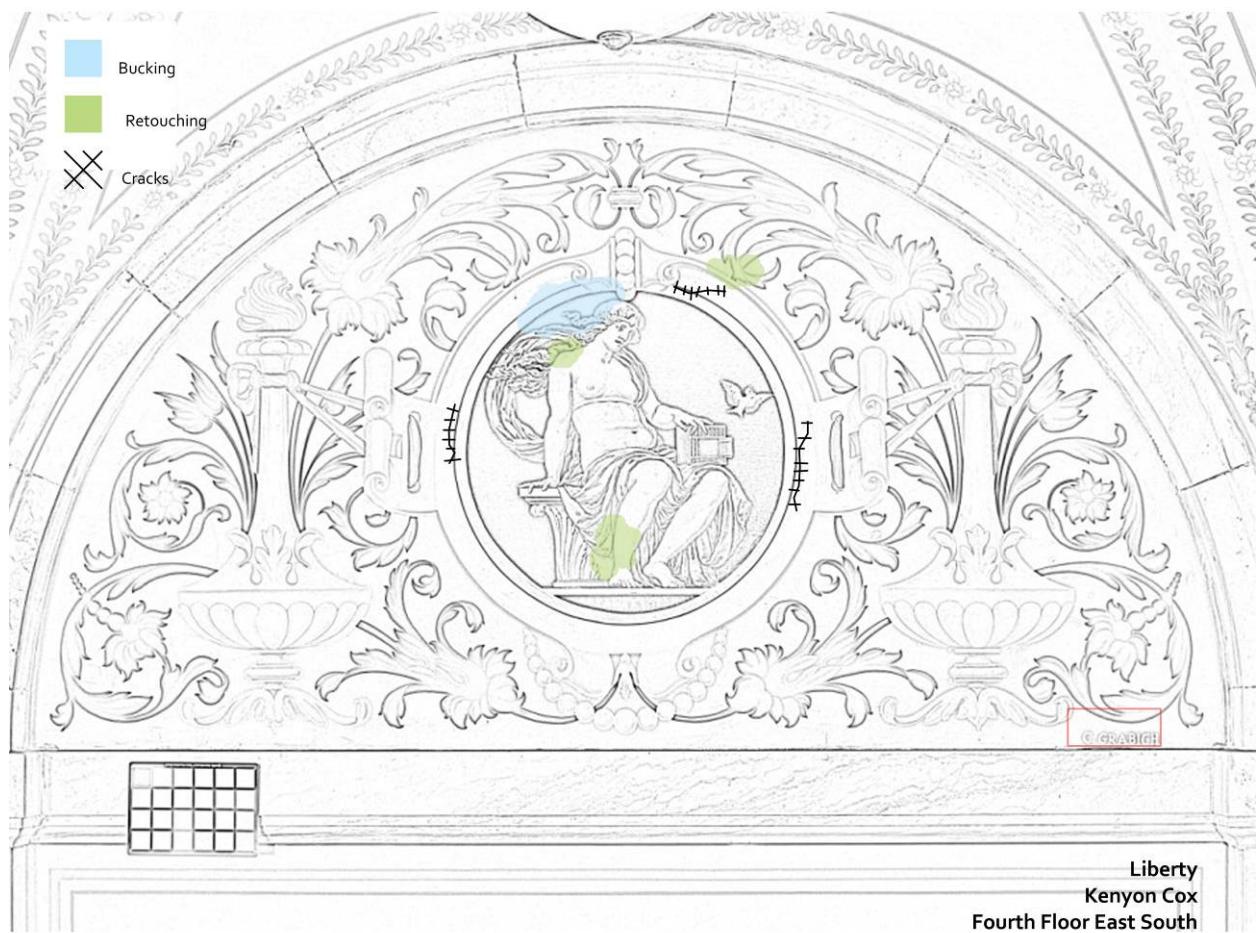
A small crack runs along the top left of the medallion, directly above an area that sounds hollow and may be structurally compromised behind the canvas. The fact that this area has been heavily reworked suggests that it may have been previously damaged by water infiltration.

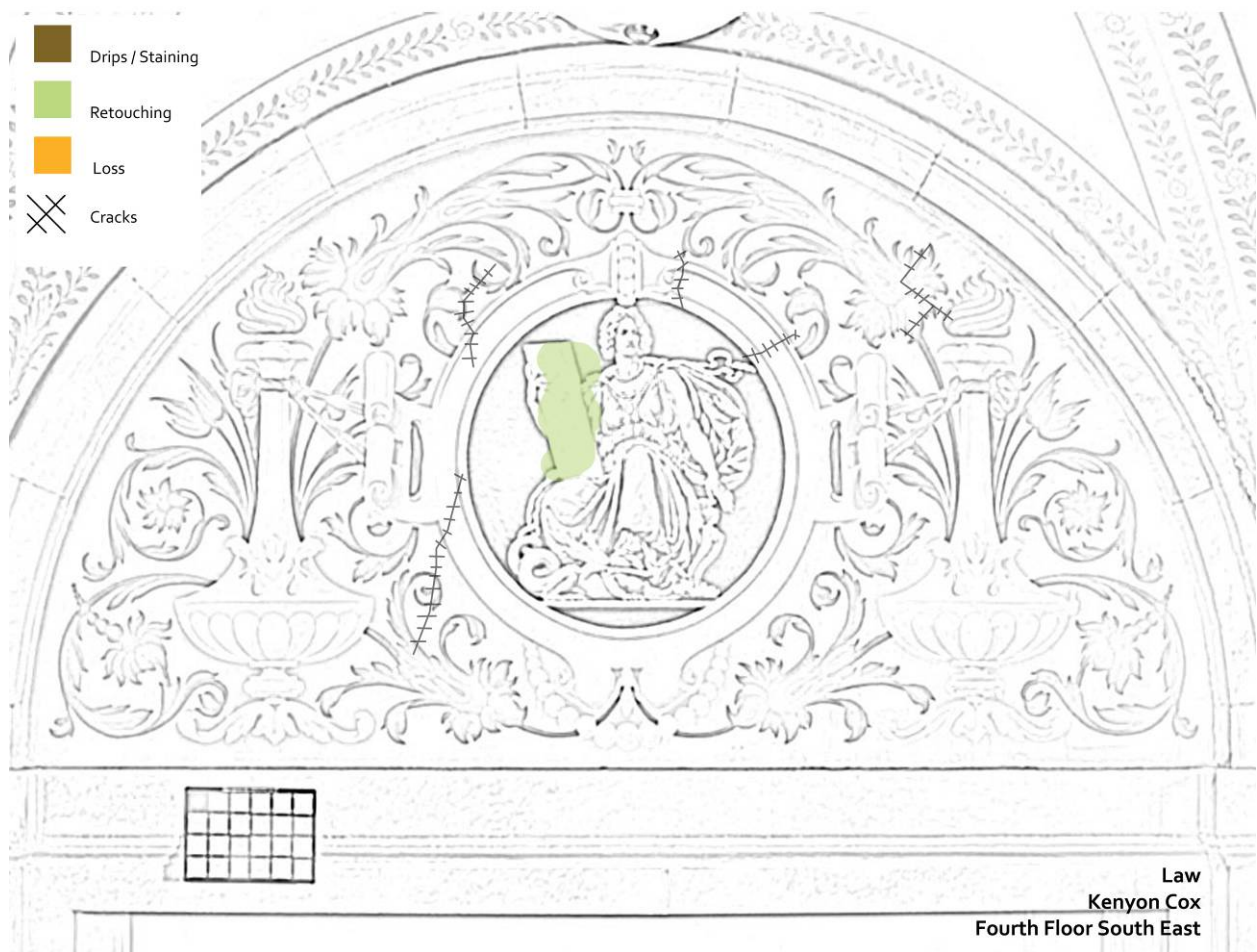
The canvas appears well adhered to the plaster and in plane. Several prominent cracks appear in the plaster, the majority of which radiate out from the medallion. A large crack runs through the plaster to the upper right of the lunette as well. The fact that the plaster has been entirely repainted, combined with the fact that the vaults in this area are the most severely water damaged, suggests that it may have been previously damaged by water infiltration.

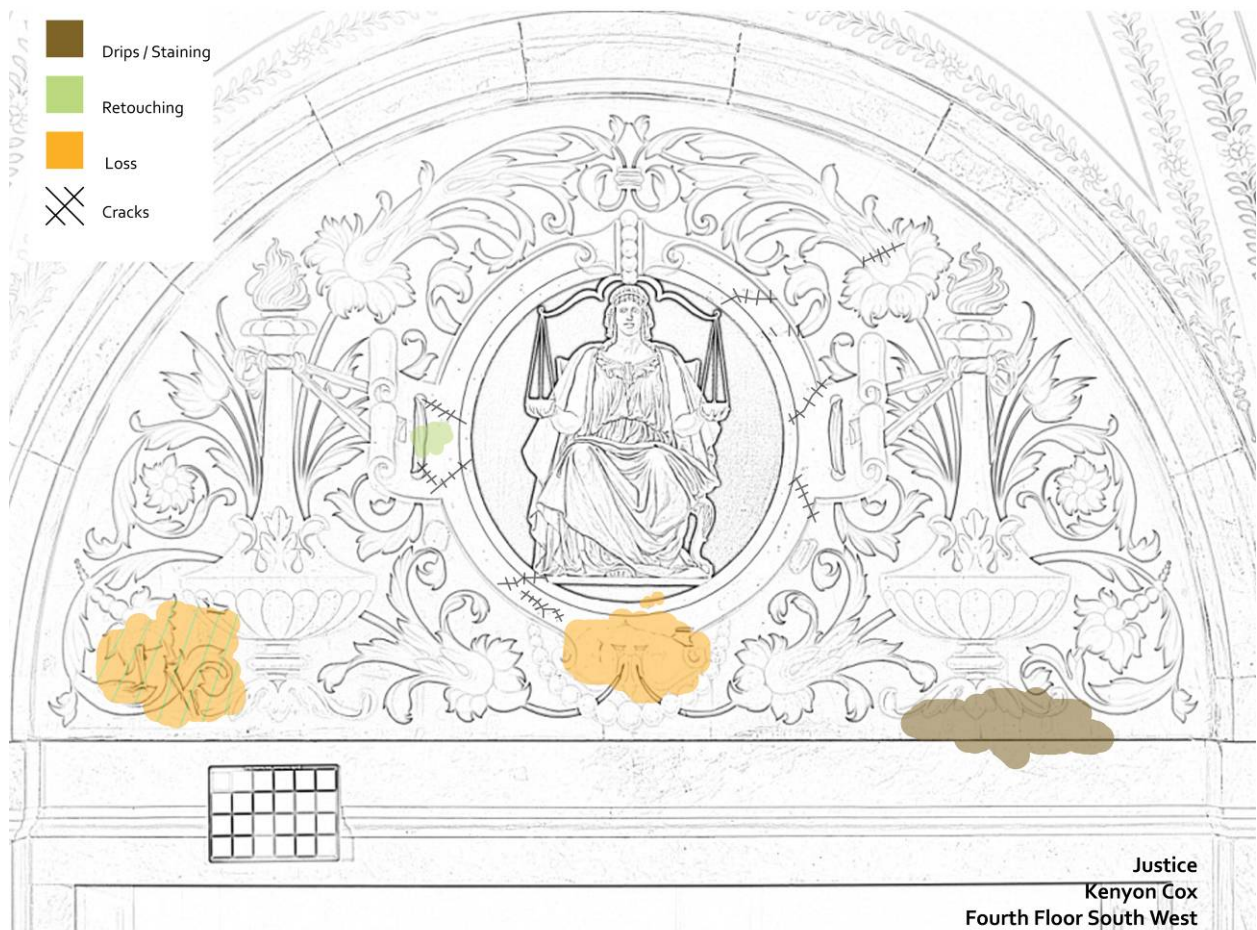
The canvas appears well adhered to the plaster and in plane. A network of cracks appears in the plaster, radiating out from the canvas. All the cracks were sounded and appear stable.

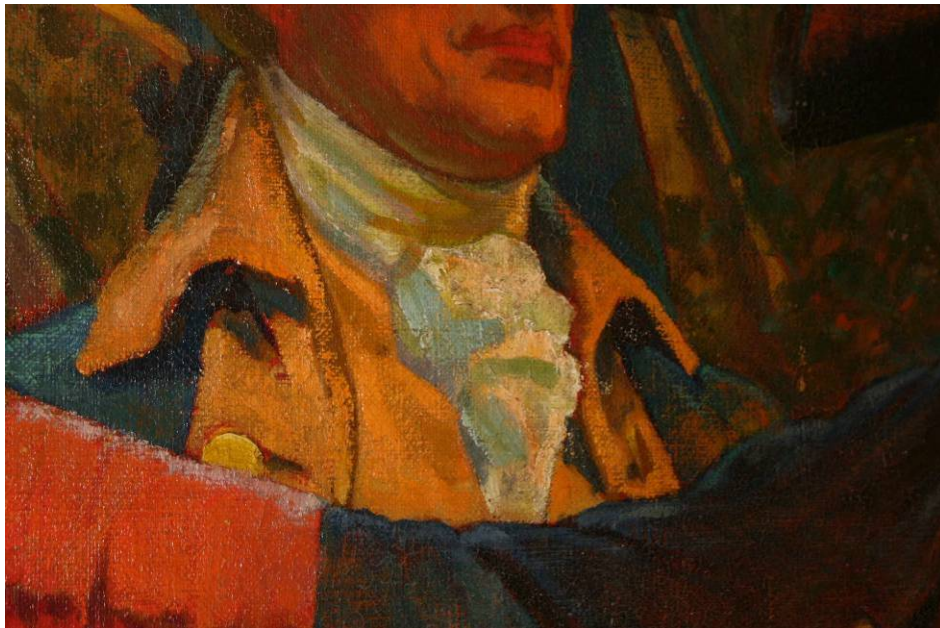
The paint medium appears to be an oleaginous paint medium. It was applied with a brush, with relatively freer brushstrokes than Millet's two adjacent murals. There are some limited visible brushstrokes and *impasto*, as seen in the soldier's cravat, lower right. The paint is predominantly applied in an opaque palette (Figure 1.)

Figure 1. "General Washington at Fort Lee..." Detail of impasto, heavy brush strokes

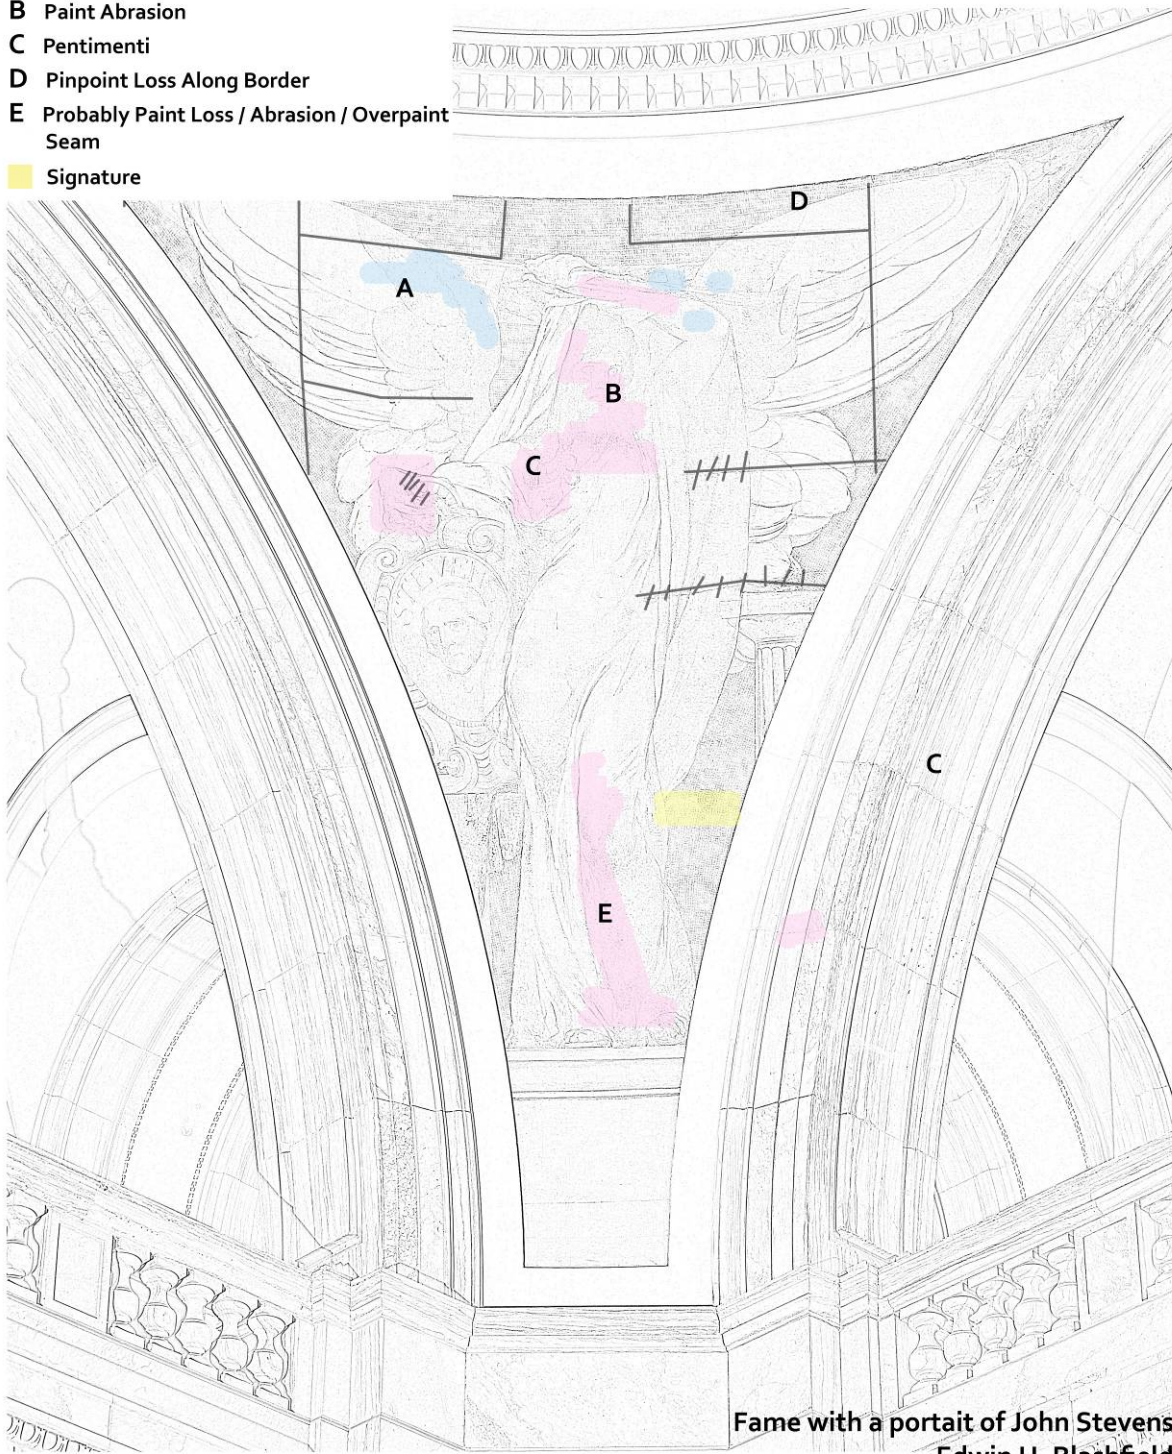
Fame with a portait of John Stevens
Edwin H. Blashfield
South East Corner

Area A: upper third of mural, in area depicting the angel's wings, there are distortions that are probably isolated areas of canvas delamination due to localized adhesive failure or distortions in the substrate

- A Blisters / Fills
- B Paint Abrasion
- C Pentimenti
- D Pinpoint Loss Along Border
- E Probably Paint Loss / Abrasion / Overpaint Seam
- Signature

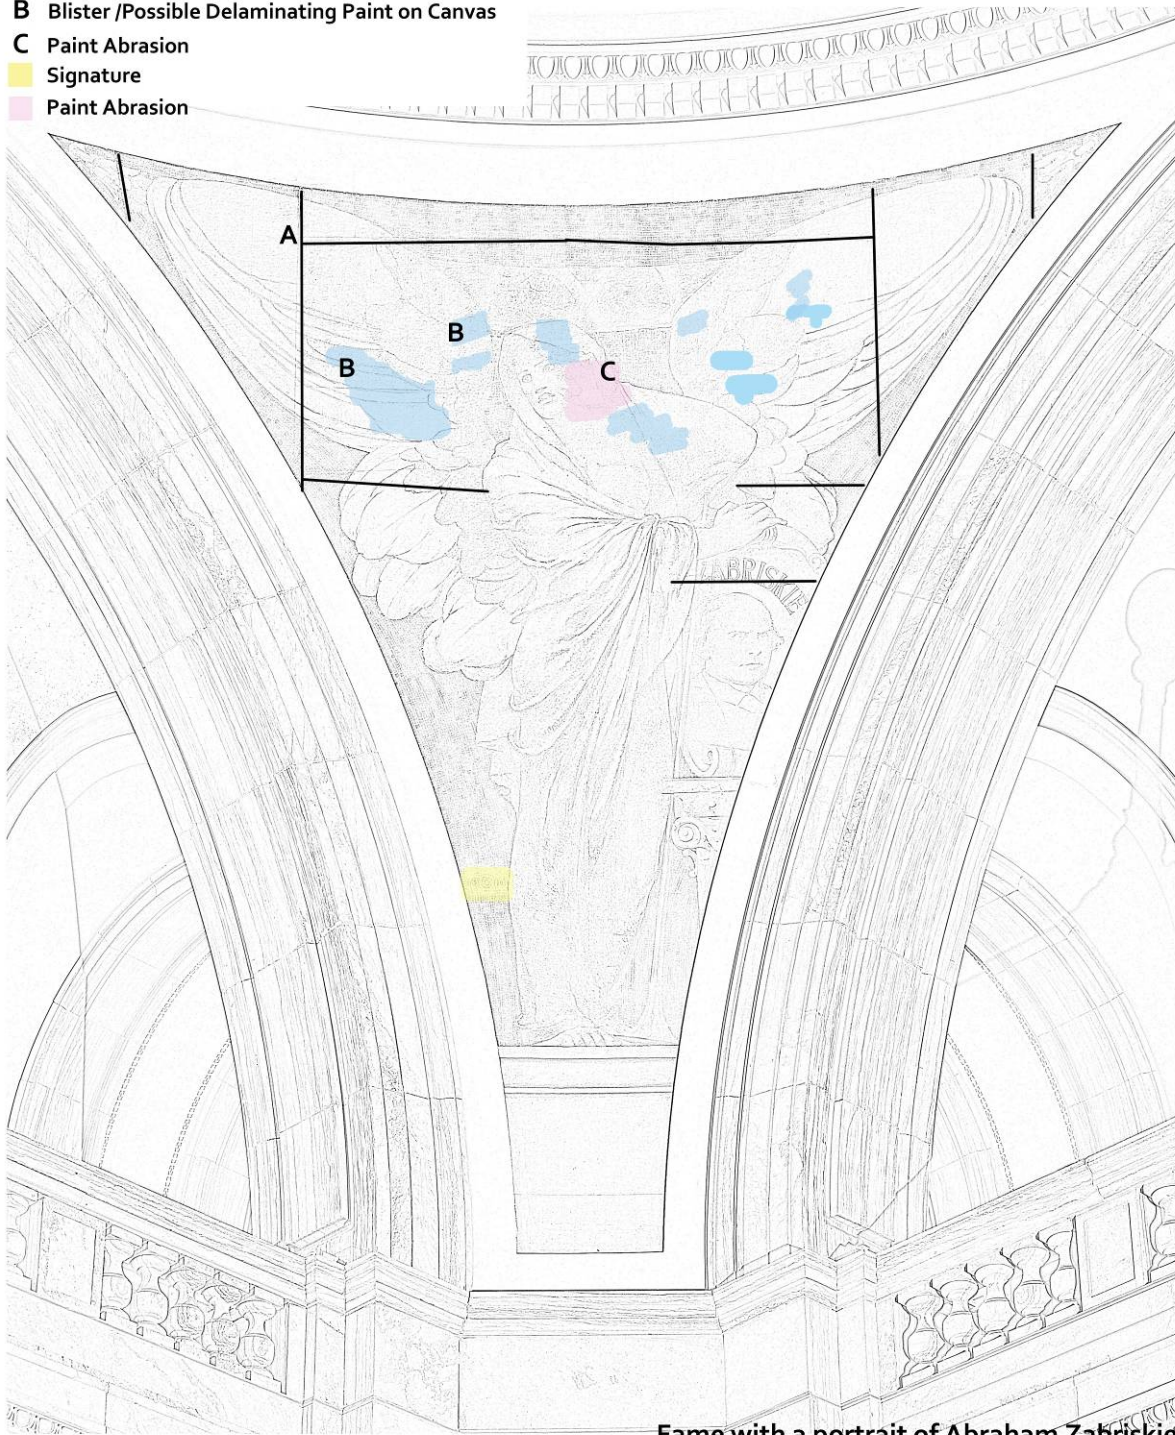
Fame with a portrait of Abraham Zabriskie
Edwin H. Blashfield
South West Corner

Area B, upper third of the mural, in the area depicting the angel's head and wings, the distortions are probable canvas delaminations, possibly emanating from the plaster

- A Lifting Seam
- B Blister /Possible Delaminating Paint on Canvas
- C Paint Abrasion
- Signature
- Paint Abrasion

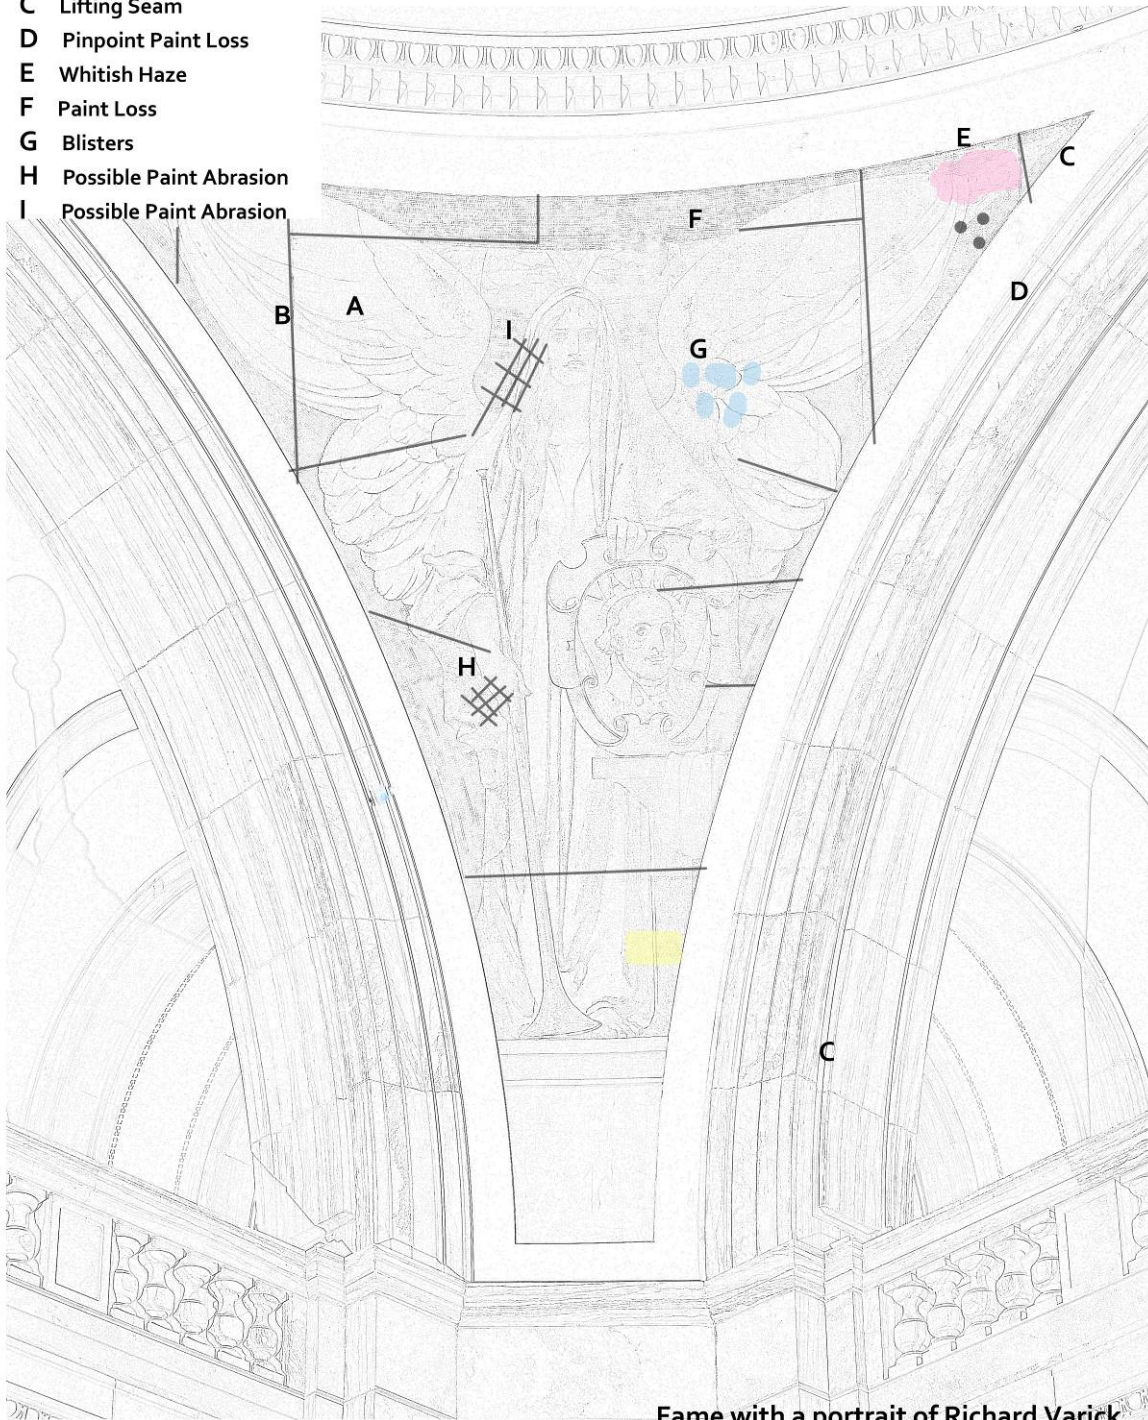
Fame with a portrait of Richard Varick
Edwin H. Blashfield
North West Corner

Area G: upper left quadrant in area depicting angels wing, small blisters that may be delaminating canvas, due to adhesive failure or planar distortion emanating from the plaster

- A Paint Loss
- B Lifting Seam
- C Lifting Seam
- D Pinpoint Paint Loss
- E Whitish Haze
- F Paint Loss
- G Blisters
- H Possible Paint Abrasion
- I Possible Paint Abrasion

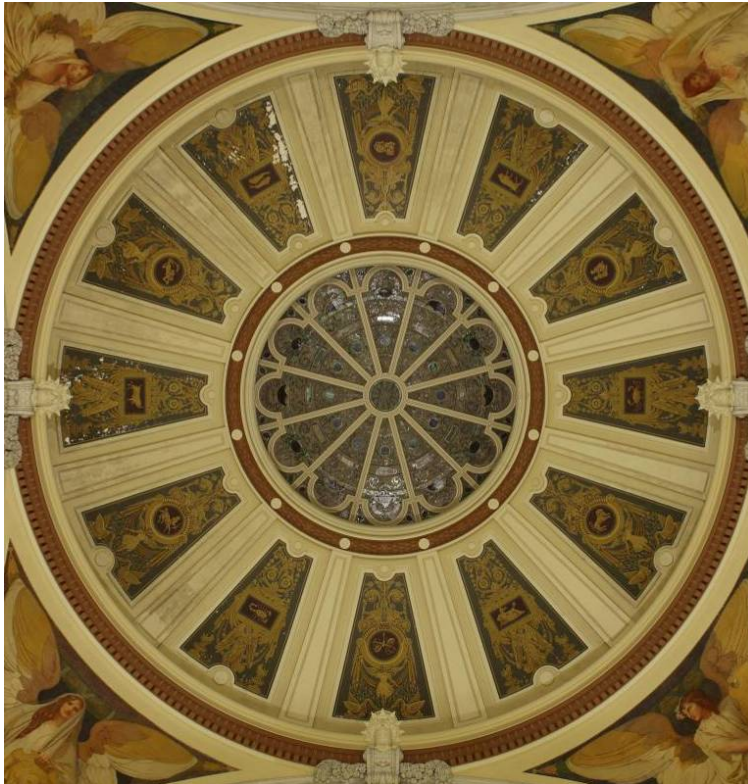
Title: "Signs of the Zodiac"
Artist: Edwin Howland Blashfield with assistants
Date: c. 1910
Signature: None Apparent
Location: Rotunda Ceiling, 4th Floor
Date Surveyed: 4/5/2012
Conservator: Amanda Stauffer

Archival information suggests that these murals are only remnants of the originals, extensively infilled and retouched. The existing paint displays evidence of major staining, drips and delamination on murals themselves as well as on the surrounding moldings. The southwest quadrant is especially compromised, although staining extends to the north end too, though. Approximately 14 square feet of losses requiring compensation were noted, and 24 square feet of flaking paint require consolidation (these areas are keyed into the drawing on the following page). However, as hands-on access was not provided, a more in-depth survey should be carried out after a scaffold is erected.

The murals are painted on plaster, which appears to have suffered from varying degrees of water infiltration and damage over the past century. The substrate should be tested with a moisture meter before any restoration work proceeds, as it is important to ensure that the substrate is dry and can promote sound adhesion with any new paint applications.
